St. Mary's Conservation Project

St. Mary's Church, Athenry, Co. Galway

Conservation Architect's Report on Works undertaken Dec 2014 - March 2015

St Mary's Athenry.**Conservation architect's report on consolidation works commenced Dec 2014**

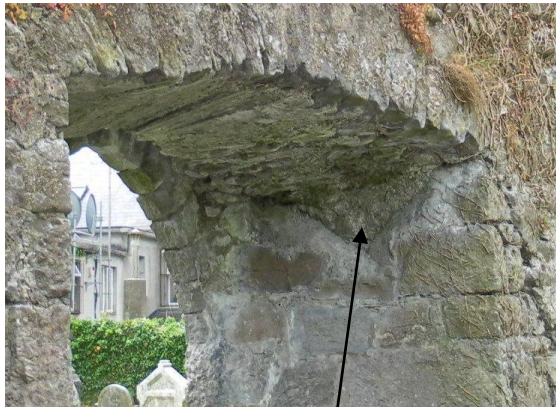
Before works.

Late 20th century cement based repair

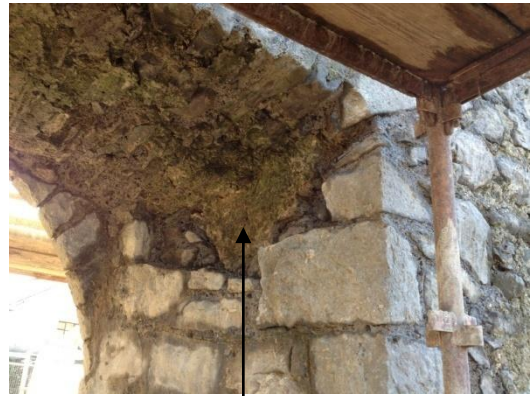
After works

Cement based repair was removed and early soffit and reveal of arch exposed. (Present form of arch is later - see archaeologist's discussion.) Extensive grouting was carried out behind the existing later reveal.

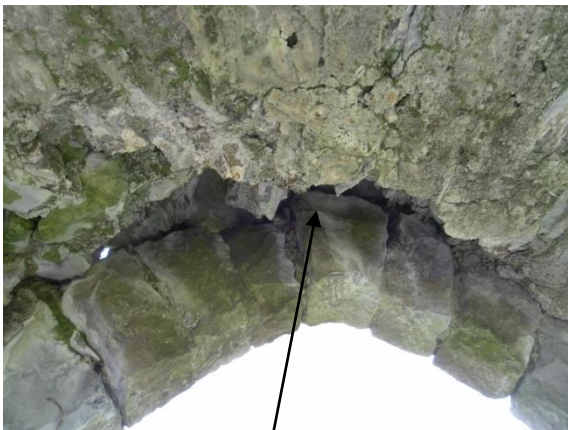
Before works. Gap where stones and mortar fallen away.

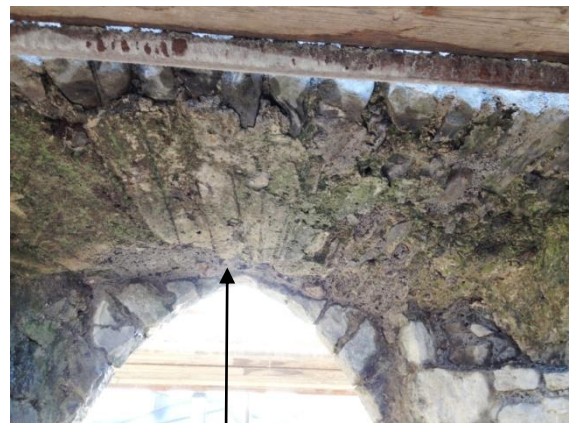
After works

Gap where plank centred vaulting had fallen away was repaired by plugging with suitably sized rough stones and mortar. Repair was held back from face of original work.

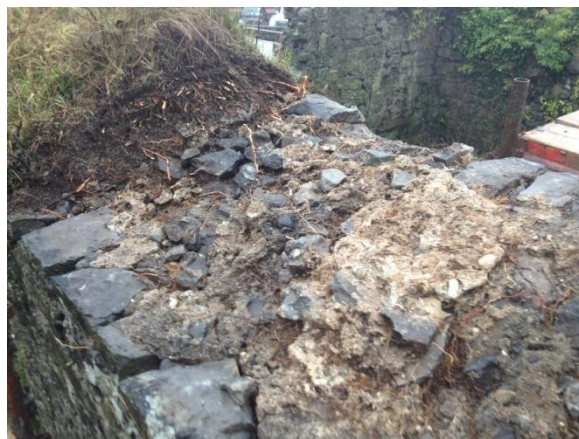
Vegetation growth on the wall head was vigorous and had loosened and dislodged smaller stones in the exposed core of the wall and was penetrating the joints between facing stones. Large amounts of clay/humus and multiple roots of plants and small trees were removed prior to re-bedding of stones and consolidation of the wall head.

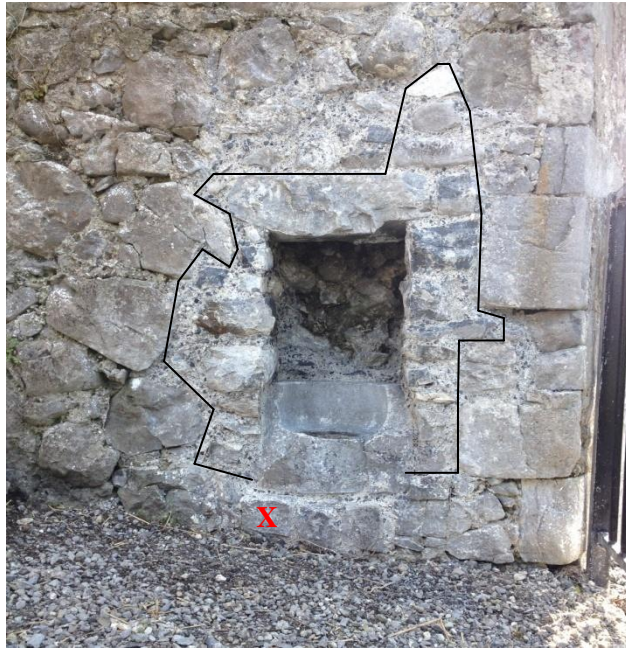
After works, line outlines area where stones were introduced.

It was concluded that this was not the original location for this font (see archaeologist's discussion) but that it should be left as found and the 'niche' stabilised. Method of repair was agreed with National Monuments DAHG. Stones for repair, including long stone used as lintel, were sourced in the rubble pile at the base of the west wall of nave. Stone was not dressed. Sides were built up to support lintel. Stone X is part of the broken edge of font.

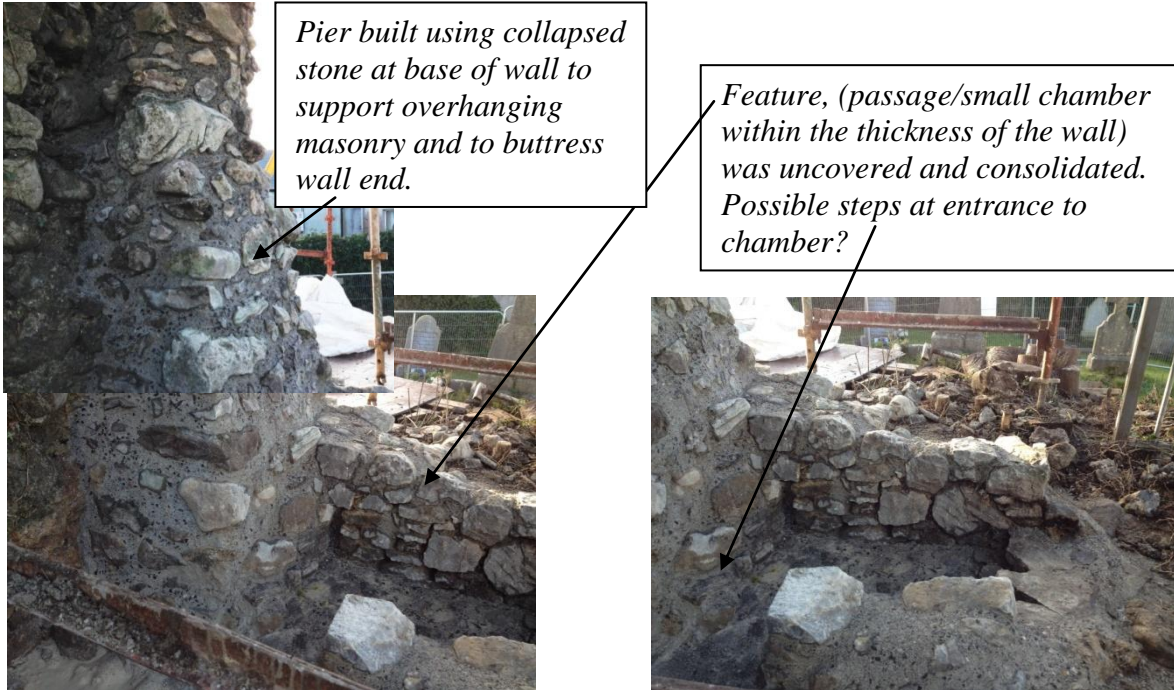
During works, view of base of west wall of nave looking down from above.

During works a hidden feature was uncovered in the depth of the wall as the pile of collapsed and dumped stone was removed. See Archaeologist's discussion - probably a late feature. Marked in photo above by red dashed line.

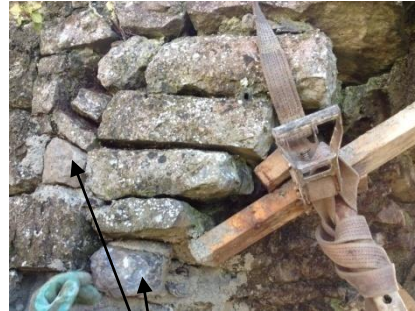
*Before work
Cement based fairly recent repair (late 20th century)*

Work in this area included removal of modern cement based repair. Remnant of cut stone mullion used in this repair was removed and stored in south transept with other displaced cut stone remnants. New repair was made using lime/sand mortar and consisted of re-pointing and pinning work. A few larger rubble stones sourced under archaeological supervision were introduced where necessary to support unstable stonework. These were sourced from fallen stone immediately below this window or in the stone dump in the north corner of the graveyard against the boundary wall.

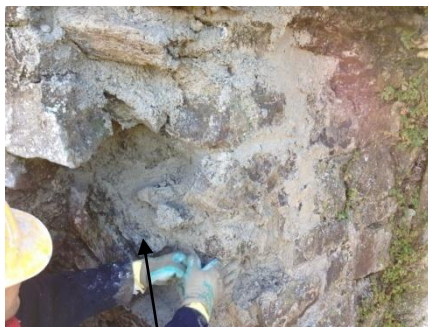
Consolidation taking place around partly visible remnant of 13th century arch (see Archaeologist report)

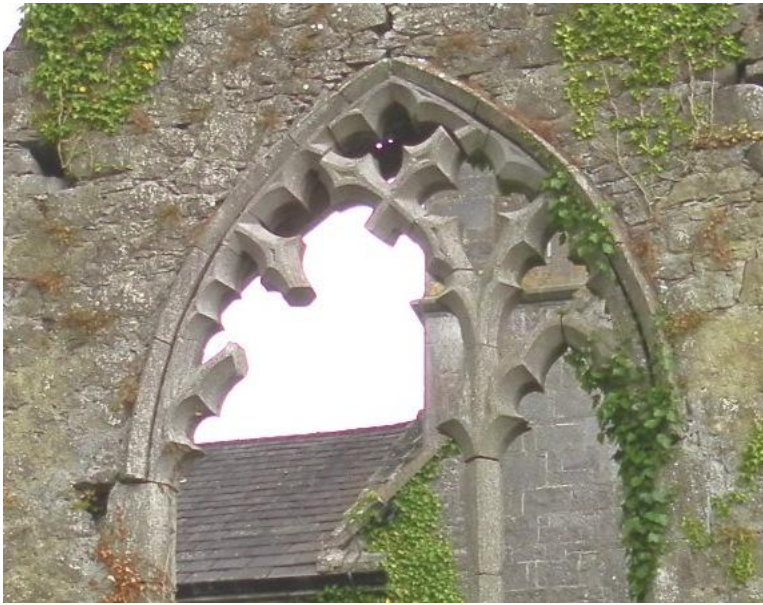
Tracery:

Before works, many stones out of alignment.

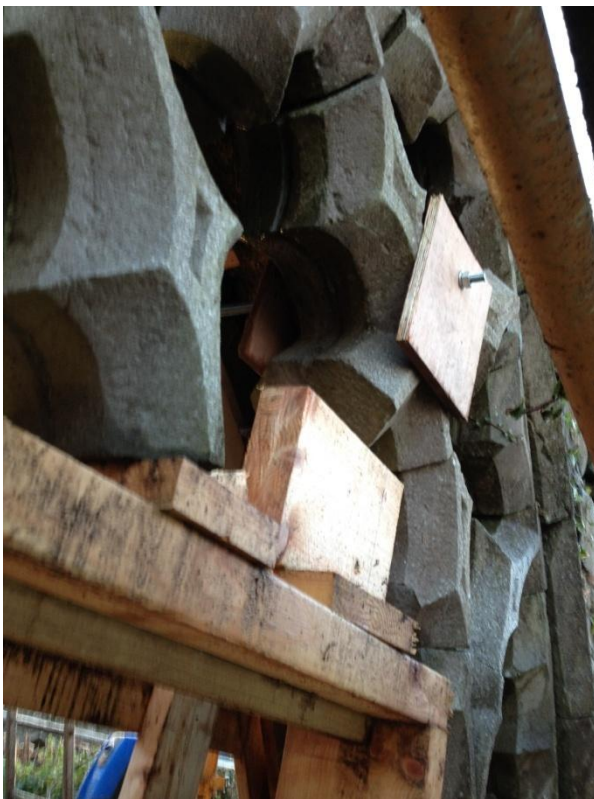
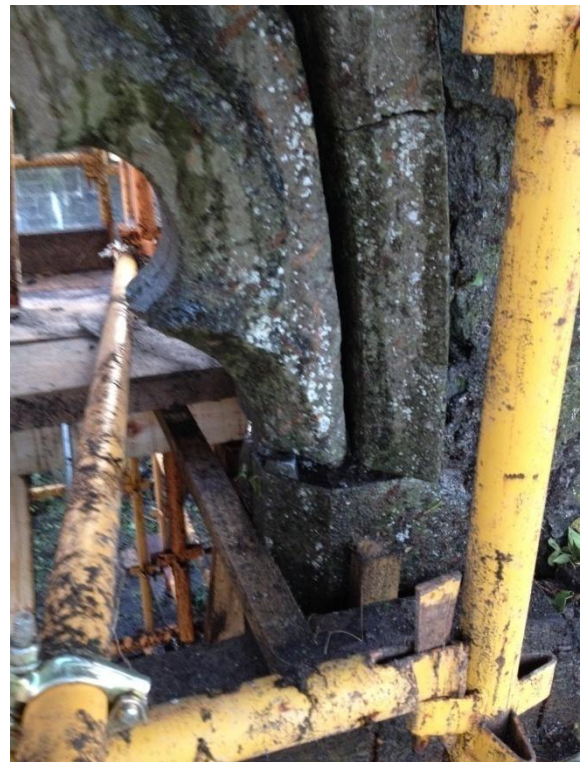
Photos show the extensive propping. Slipped stones, mortar completely washed out.

Elaborate propping of the stonework in this area was necessary before any works could be undertaken. When this was in place it was possible for many of the displaced stones to be carefully eased back into their original positions. Ropes were used to hold them temporarily in their restored positions and then pointing and wedging secured them. A fine sand / NHL 3.5 mix was used for pointing and thin lead pieces were used as shims in some joints where necessary to secure the cut stones. (Lead was considered preferable to the stainless steel shims originally proposed as its softer nature would be more forgiving in the stonework joints.)

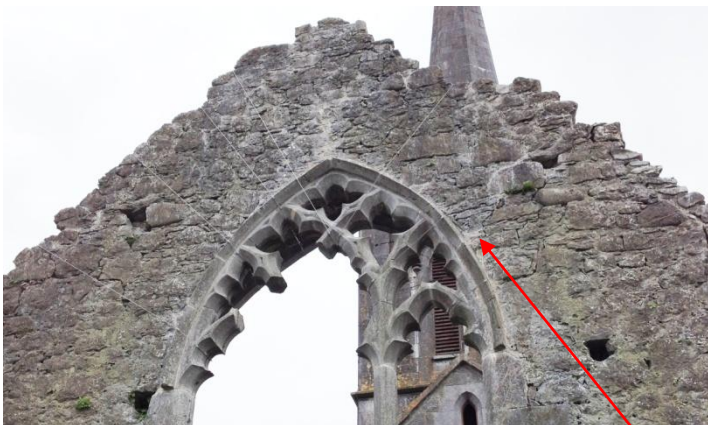
*Completed works, external face
Stainless steel tie wires are barely visible*

Stainless steel tie wires were put in place as per engineer's specification to ensure no possible future movement of incomplete stone tracery. Plastic sleeves were used to protect stone at vulnerable pressure points but wires were not over-tightened.

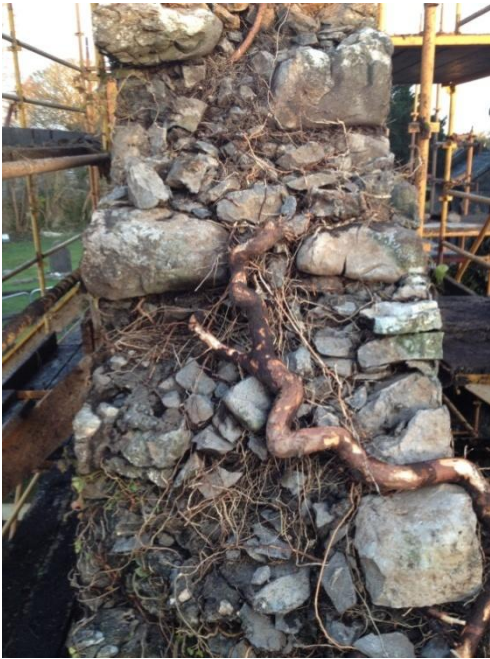
*Before works, west side of gable
Extensive root system caused huge damage.*

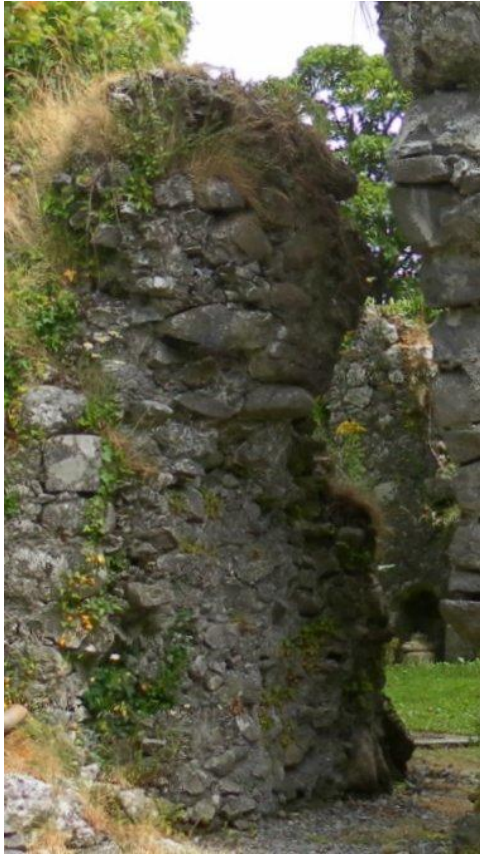
Close up view prior to repair

Repair in this area consisted of the rebuilding of masonry where necessary to support overhanging unstable facing stones at higher levels. Because of the relatively shallow depth of the missing facing stones it was necessary to build the new masonry out to the face of the wall. It was not possible to achieve sufficient stability by using shallow stones and keeping back from the wall face and finishing 'rough raked' which was successfully done elsewhere. Re-pointing and pinning was undertaken where necessary.

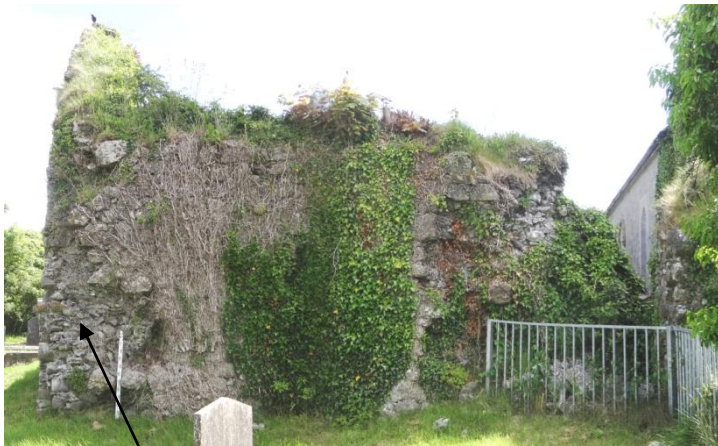
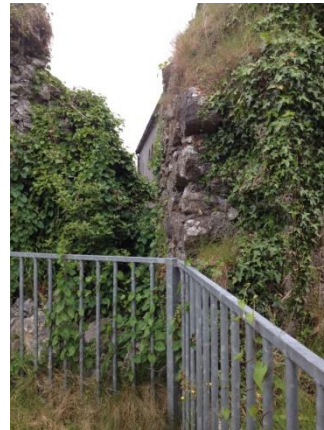
Above, views of west wall from the west prior to works
Most quoins stones had been robbed out but these were not reinstated as it would have been necessary to source new cut stone. A reasonable degree of stability was introduced by rough racking (to be monitored into the future).

Root systems were so extensive and roots so large that it was not possible to remove many of them without dismantling much of the wall. This was not an option so the roots were left in place and treated with 'Roundup' (glyphosate). They were drilled and plastic tubes were inserted into the roots and these were left in place for further applications of treatment on an on-going basis until the plants would be completely dead.

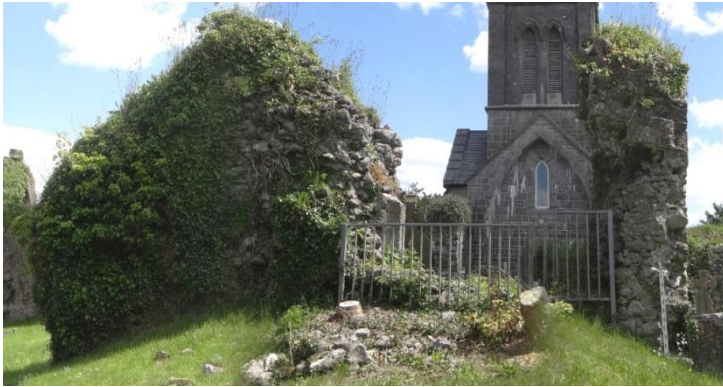
Crack extending down gable wall which may have been the reason for the building of buttress?
