St. Mary's Conservation Project

St. Mary's Church, Athenry, Co. Galway

Conservation Architect's Report on Works undertaken Dec 2014 - March 2015

St Mary's Athenry.**Conservation architect's report on consolidation works commenced Dec 2014**

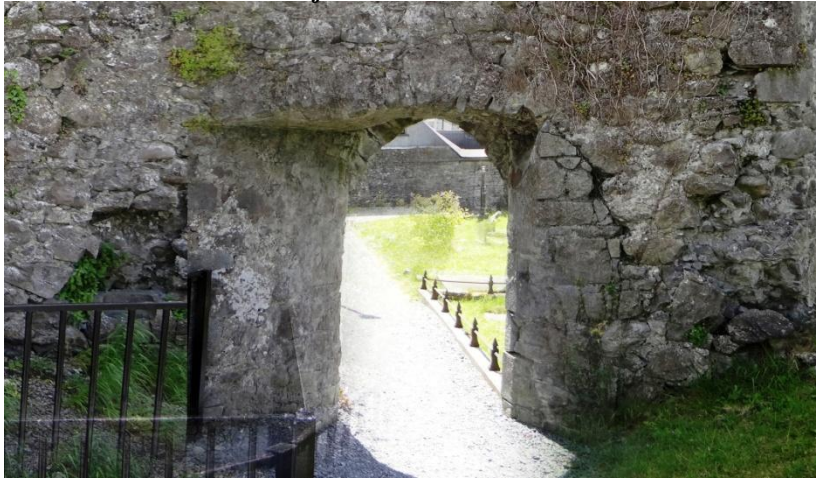
Before works

Work in this area consisted of removal of any vegetation; re-pointing and pinning of stonework on internal and external faces; repair of the vault behind the cut stone arch on the external face; removal of 20th century cement based repair on western reveal of archway and extensive grouting behind this western reveal. Only a small amount of grouting proved necessary above the arch - about 300 litres. Vegetation was removed from the wall head and it was consolidated using the rough racking technique.

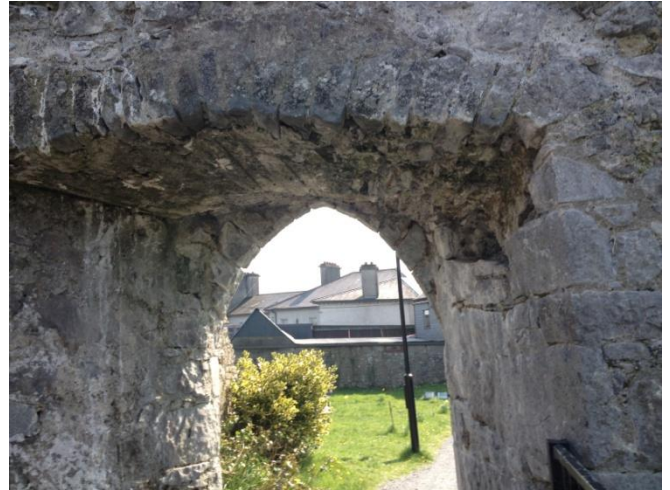
After works

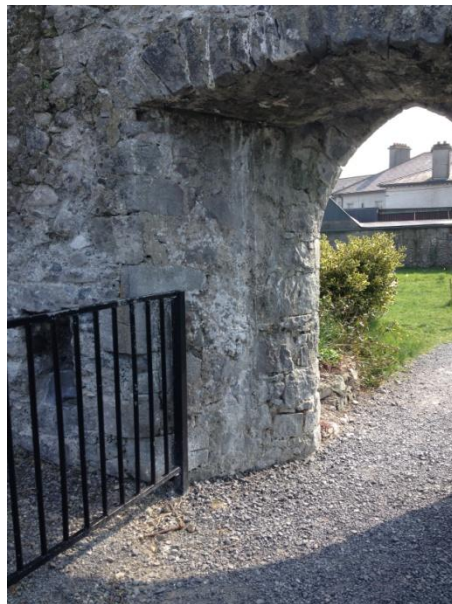
After works

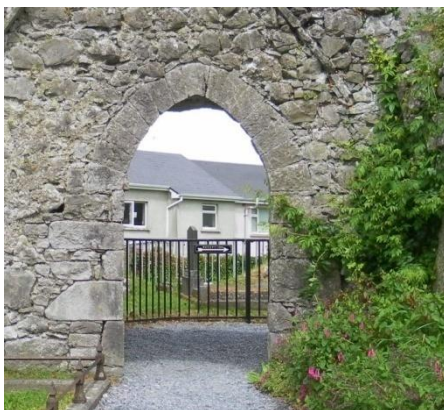
Before works

Works on the external face around the archway consisted mostly of re-pointing.

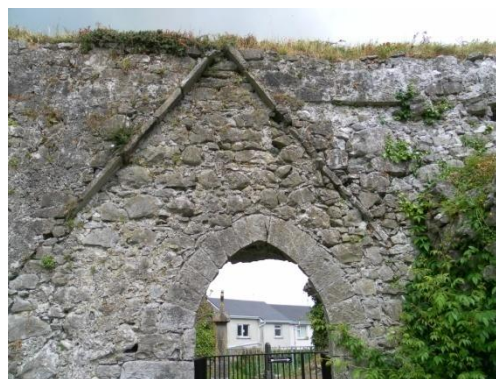
Before works

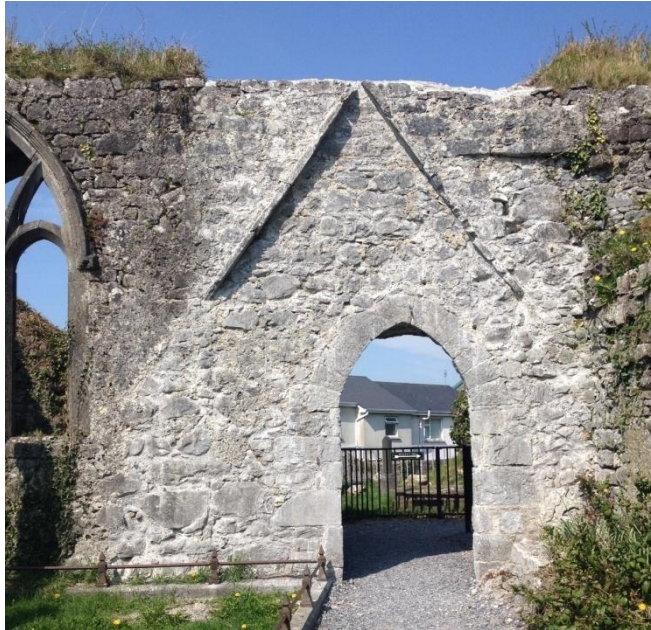
After works

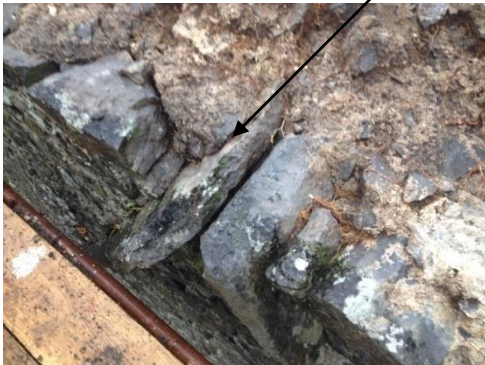
During works

Vegetation growth on the wall head was vigorous and had loosened and dislodged smaller stones in the exposed core of the wall and was penetrating the joints between facing stones. Large amounts of clay/humus and multiple roots of plants and small trees were removed prior to re-bedding of stones and consolidation of the wall head.

Wall head consolidated by rough racking, considerable amount of re-bedding of loose stone on the wall head was necessary. No stone introduced from elsewhere.

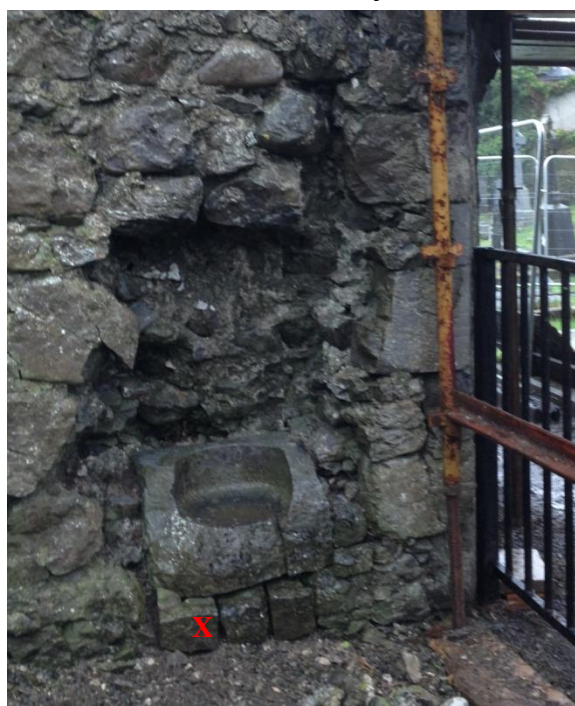
Niche with font

Before works

It was concluded that this was not the original location for this font (see archaeologist's discussion) but that it should be left as found and the 'niche' stabilised. Method of repair was agreed with National Monuments DAHG. Stones for repair, including long stone used as lintel, were sourced in the rubble pile at the base of the west wall of nave. Stone was not dressed. Sides were built up to support lintel. Stone X is part of the broken edge of font.

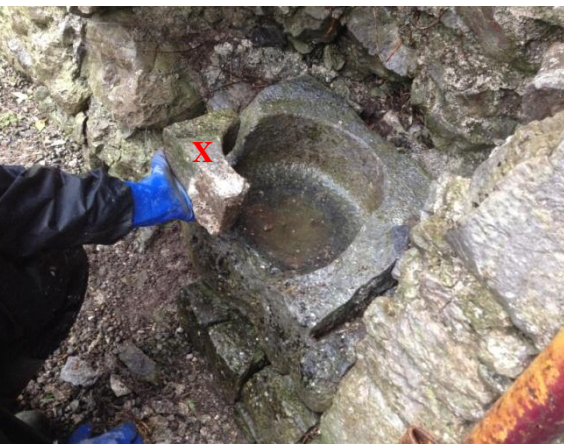
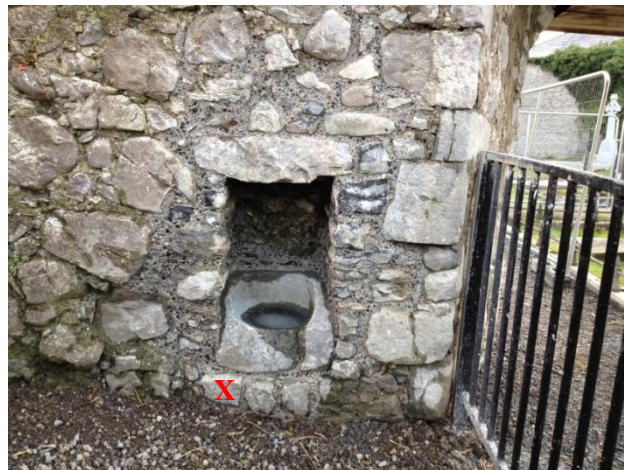
After works, line outlines area where stones were introduced.

After works, mortar still very fresh.

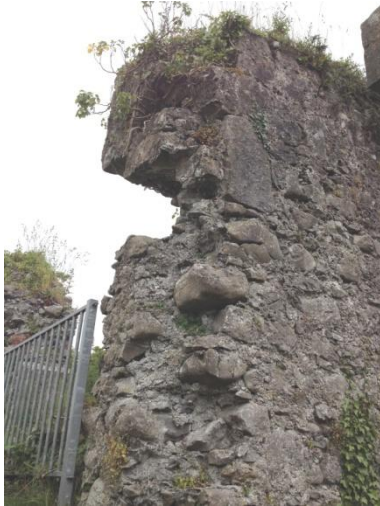
Before works, view from south-west.

Works in this area consisted of the careful removal of vegetation; removal under archaeological supervision of the extensive pile of stonework from the collapsed west wall of the nave, which may also have included some stone dumped from elsewhere; building up under unsupported stonework at the upper part of the wall and buttressing the end of the wall by rebuilding a nib of stonework - part of the west gable of the nave. Work was done using rubble stone found in-situ and coarse lime/sand mortar.

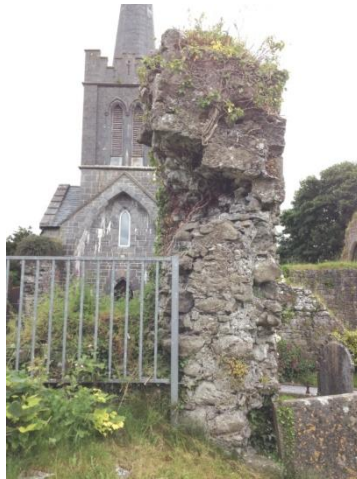
Before works, from west.

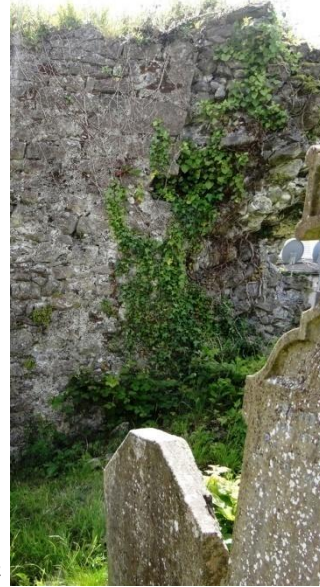
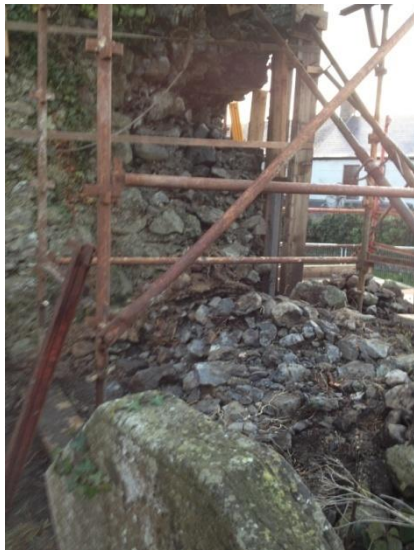
Before works, view from north

During works, view from north

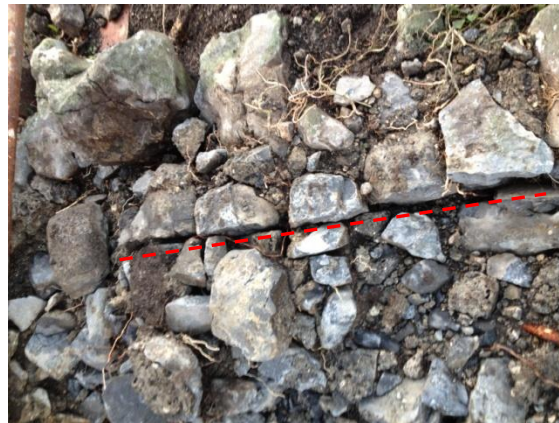
During works, view of base of west wall of nave looking down from above.

During works a hidden feature was uncovered in the depth of the wall as the pile of collapsed and dumped stone was removed. See Archaeologist's discussion - probably a late feature. Marked in photo above by red dashed line.

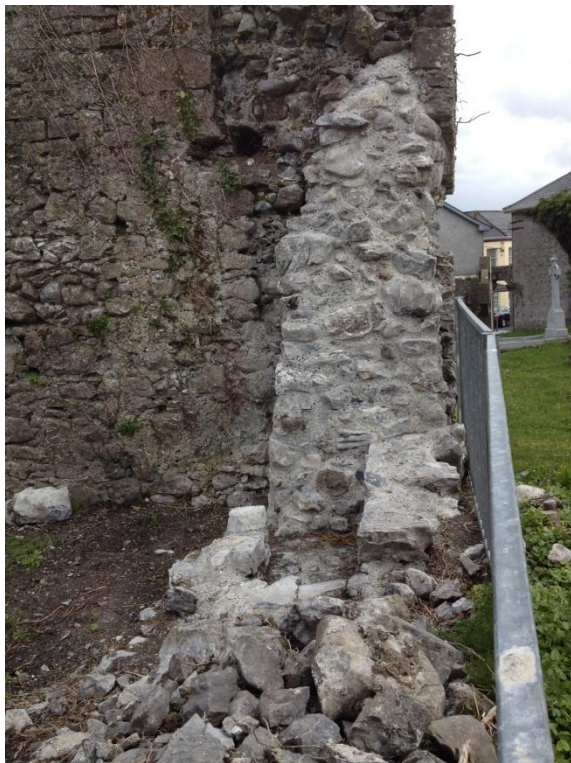
Completed consolidation work viewed from north

The face of buttressing and supporting stonework introduced into the structure was held back as far as possible from the original faces of the walls. The style of stonework attempted to match core work while of necessity also functioning structurally.

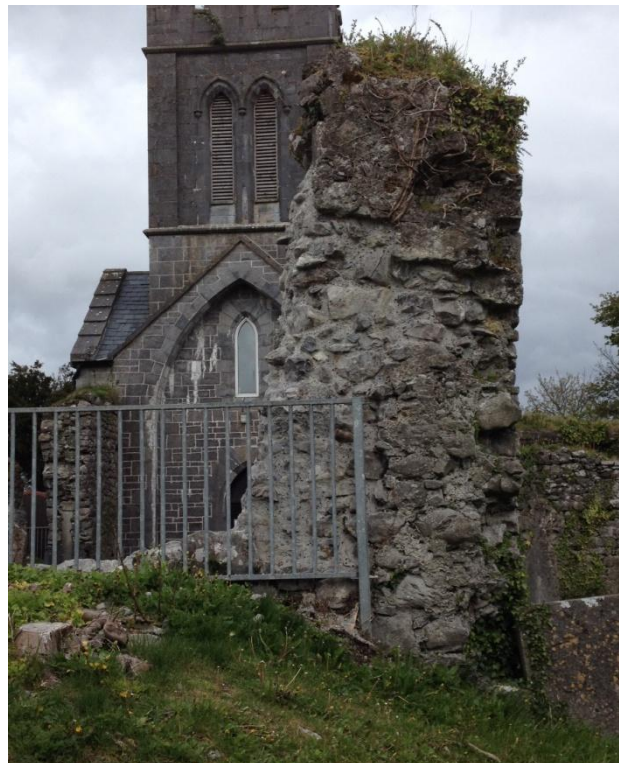
Completed work viewed from west.

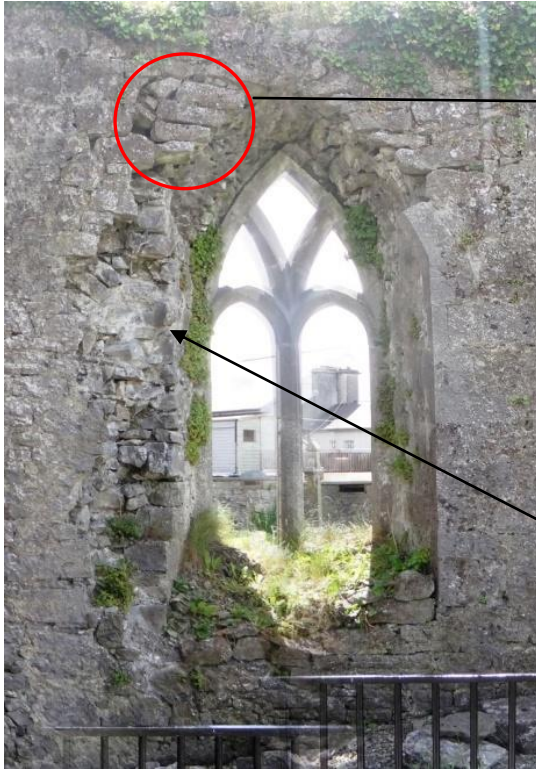
During work. Stones introduced to support stones in danger of collapse

Work in this area included removal of modern cement based repair. Remnant of cut stone mullion used in this repair was removed and stored in south transept with other displaced cut stone remnants. New repair was made using lime/sand mortar and consisted of re-pointing and pinning work. A few larger rubble stones sourced under archaeological supervision were introduced where necessary to support unstable stonework. These were sourced from fallen stone immediately below this window or in the stone dump in the north corner of the graveyard against the boundary wall.

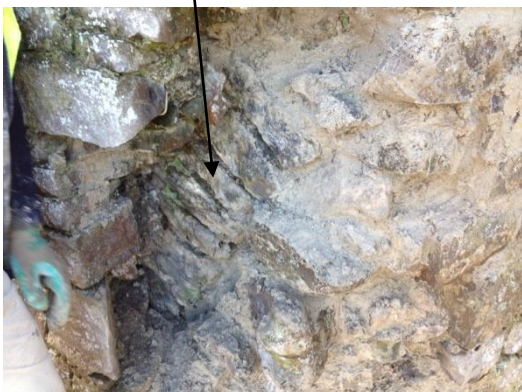
Consolidation taking place around partly visible remnant of 13th century arch (see Archaeologist report)

During works

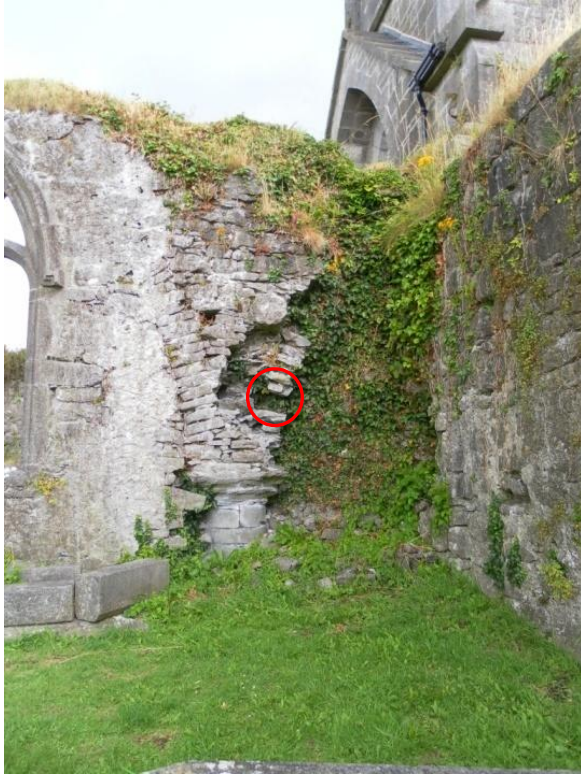
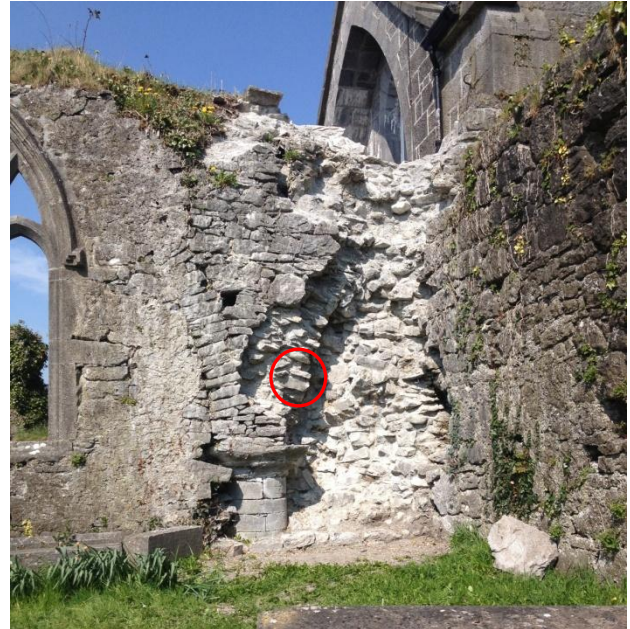
After works.

Circles indicate where 2 stones were inserted

Work in this area consisted of careful removal of extensive vegetation and cleaning off of humus and decayed mortar, followed by finishing 'rough raked'. This involved re-bedding of stone where necessary and the introduction of an occasional stone to support vulnerable overhanging stones where masonry had fallen away. Extensive pinning and pointing was undertaken and all surfaces shaped to throw off water.

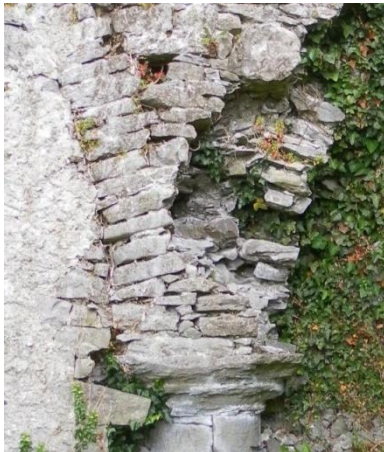
Before works

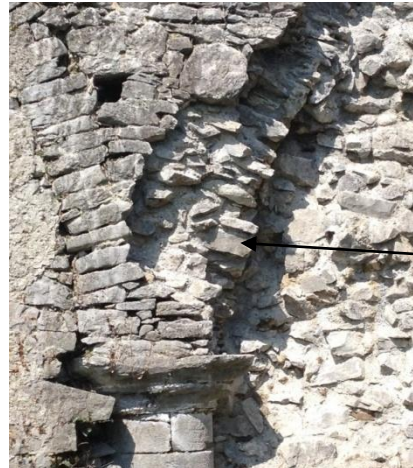
After works

Stones retrieved from fallen stone at foot of wall were inserted to support stones above.

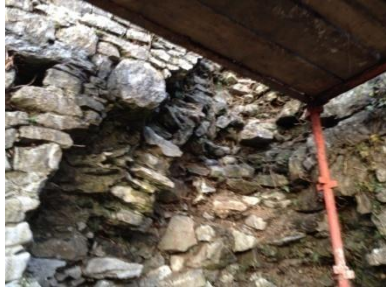
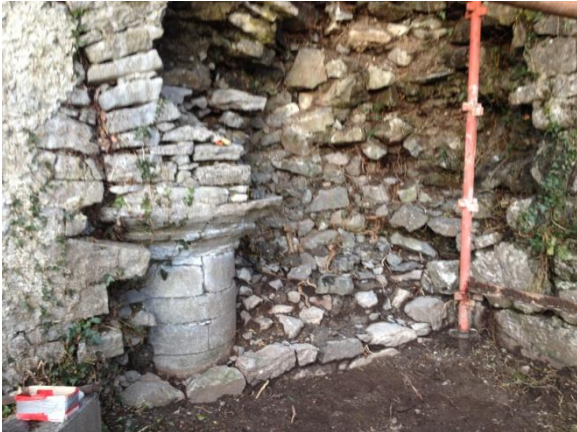
During works - vegetation cleared but consolidation not yet done.

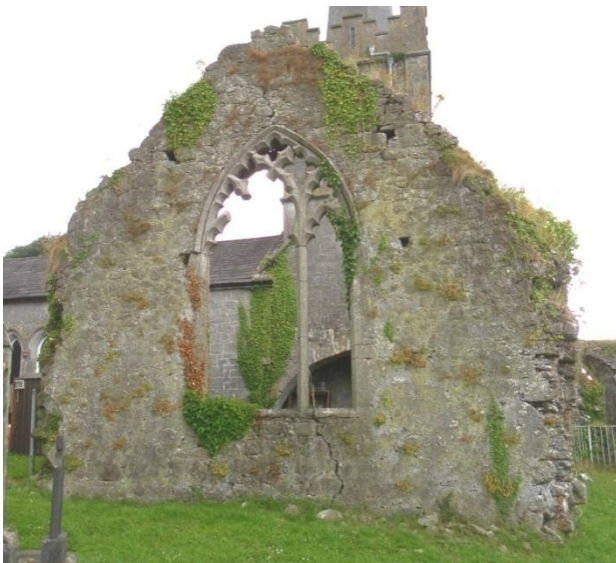
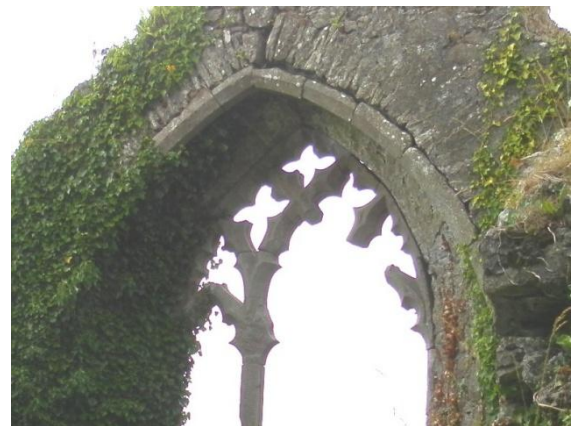
Work in this area was extensive. Much of the window tracery had collapsed and the remaining window tracery on the north face had moved considerably, and likewise the cut stone surround on the south face. Extensive root penetration and vigorous vegetation growth on the gable and west wall of the transept, coupled with the robbing out of quoin stones from the north-west corner of the gable are likely to have been the principal causes of destabilisation. Ideally the window tracery should have been restored but funds did not allow. The fallen tracery stones were retrieved and put for safe keeping in the south transept to which there is locked access.

Before works, above and after works, below.

Elaborate propping of the stonework in this area was necessary before any works could be undertaken. When this was in place it was possible for many of the displaced stones to be carefully eased back into their original positions. Ropes were used to hold them temporarily in their restored positions and then pointing and wedging secured them. A fine sand / NHL 3.5 mix was used for pointing and thin lead pieces were used as shims in some joints where necessary to secure the cut stones. (Lead was considered preferable to the stainless steel shims originally proposed as its softer nature would be more forgiving in the stonework joints.)

Grouting was undertaken as specified, using a fine sand / NHL3.5 mix with casein added. Stainless steel pins and reinforced limecrete under barge were installed as per engineer's design. Position and number of pins agreed on site with engineer and archaeologist. 7 pins were introduced. Barge was then finished in manner of 'rough racking' by reusing small stones dislodged and salvaged during removal of extensive vegetation and humus.

Stainless steel tie wires were put in place as per engineer's specification to ensure no possible future movement of incomplete stone tracery. Plastic sleeves were used to protect stone at vulnerable pressure points but wires were not over-tightened.

At sill level and below, the wall was grouted and consolidated using rough rack method and straightforward pointing up as appropriate.

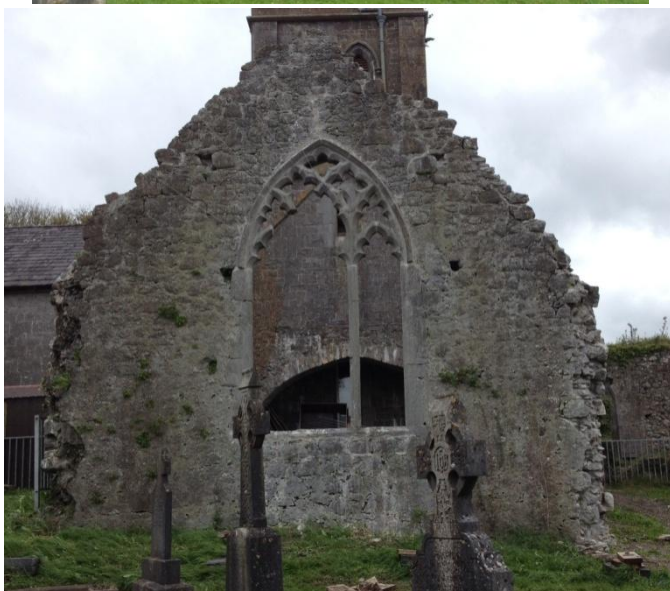
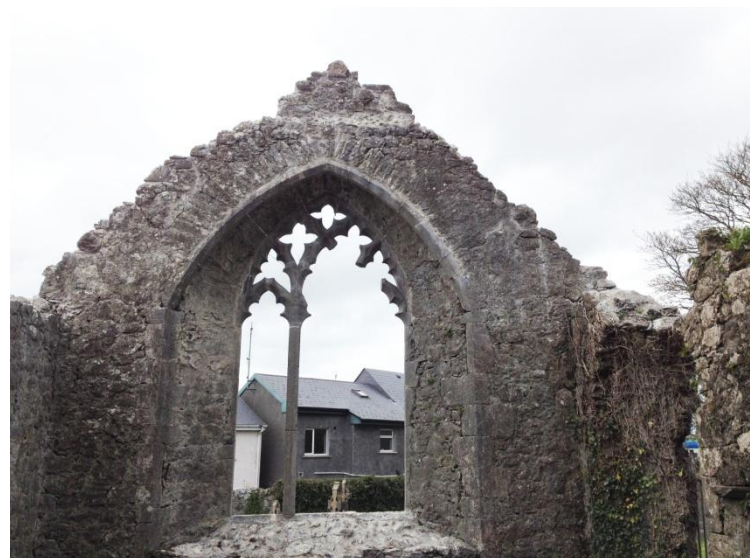
Tracery:

Before works, many stones out of alignment.

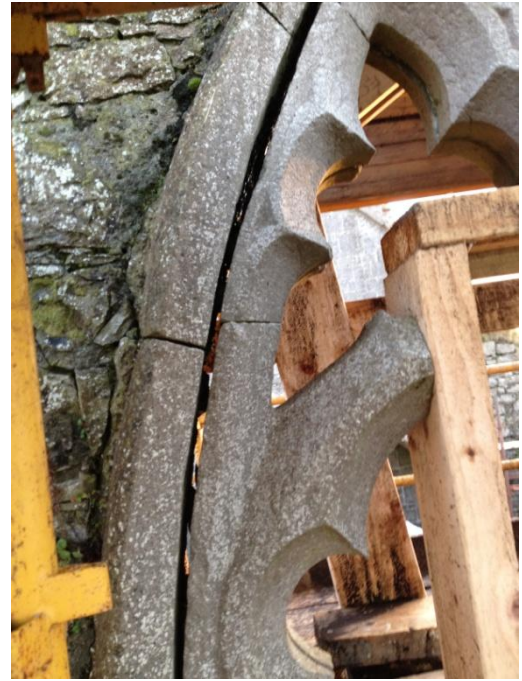
*Before works, propping in place.
Gaps between stones easily seen.*

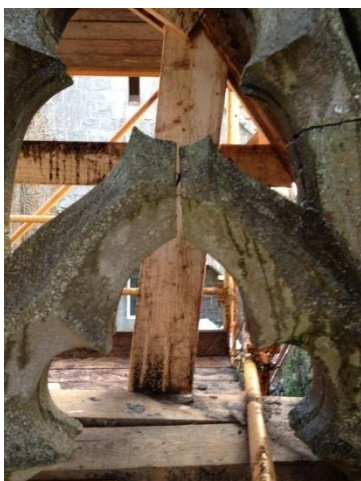
Photos show the extensive propping. Slipped stones, mortar completely washed out.

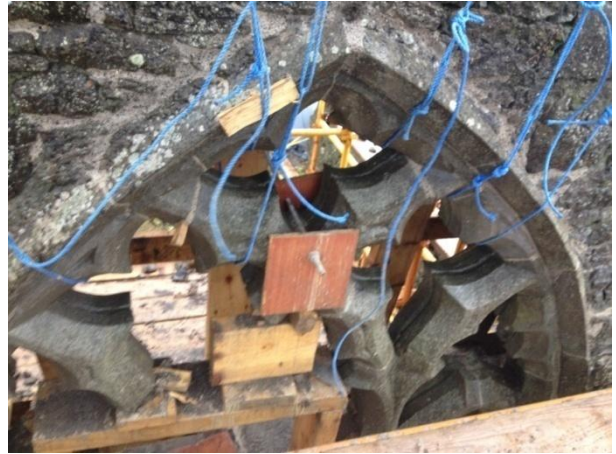
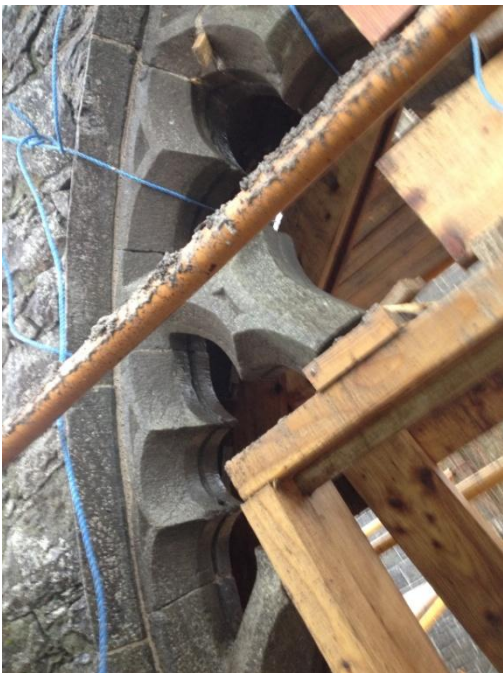
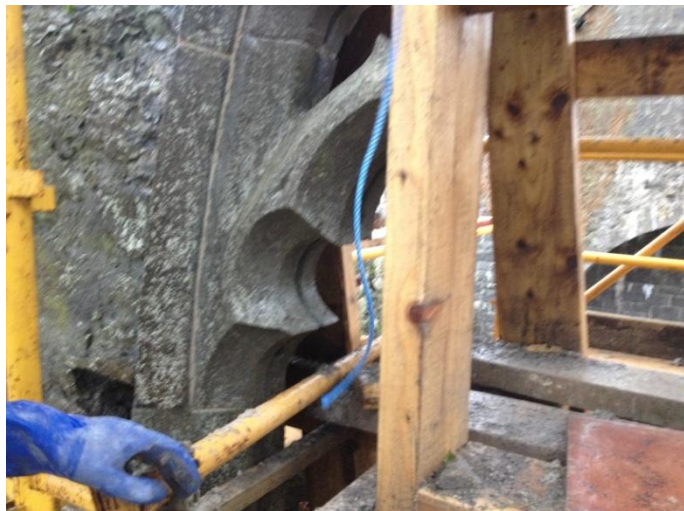
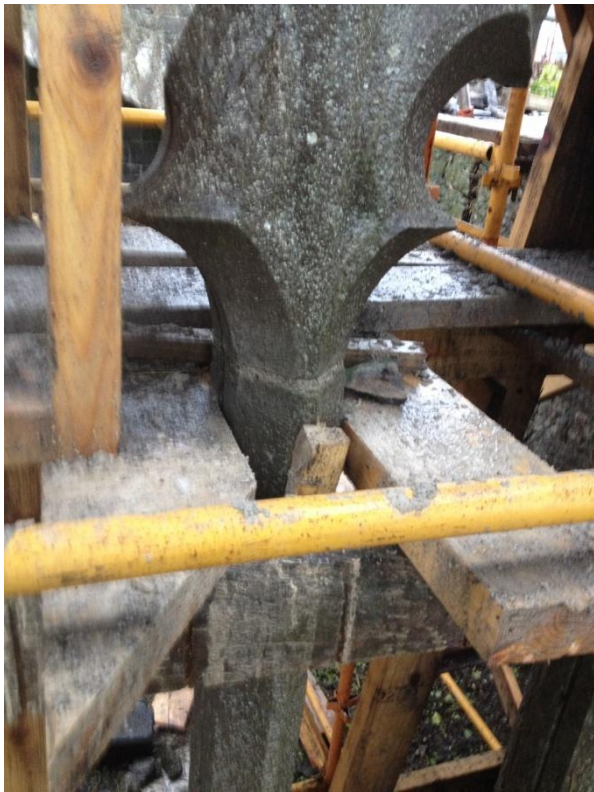
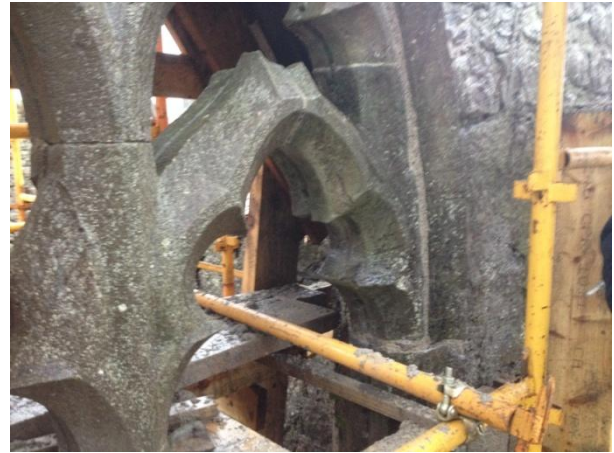
Tubes inserted for the pouring of grout.

Stones eased back into their correct positions with the aid of ropes and joints then mortared up.

Mortar set and ropes removed.

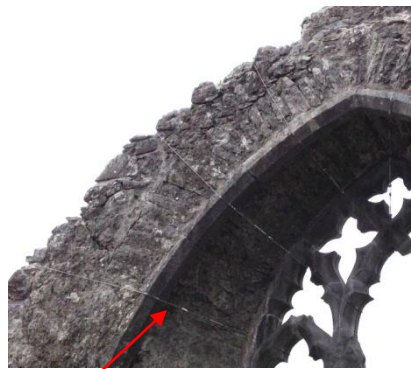
Completed works, internal face

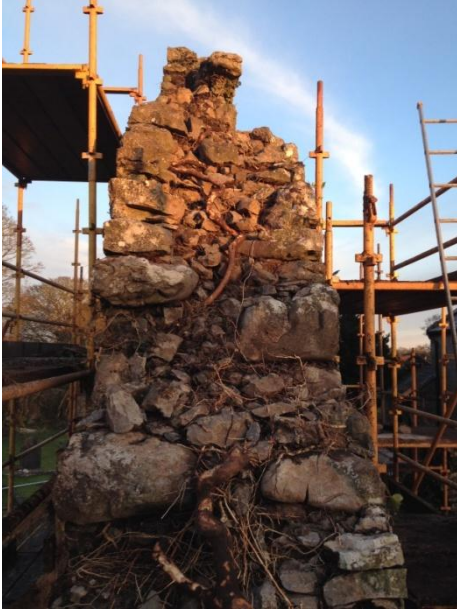
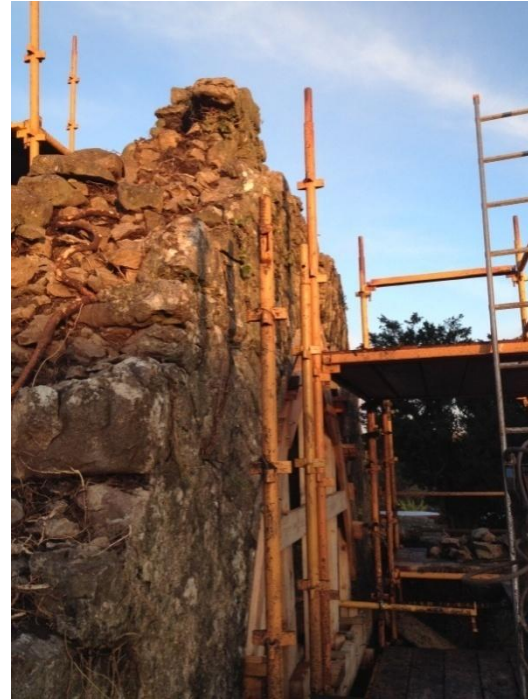
View of gable wall head from west, before works

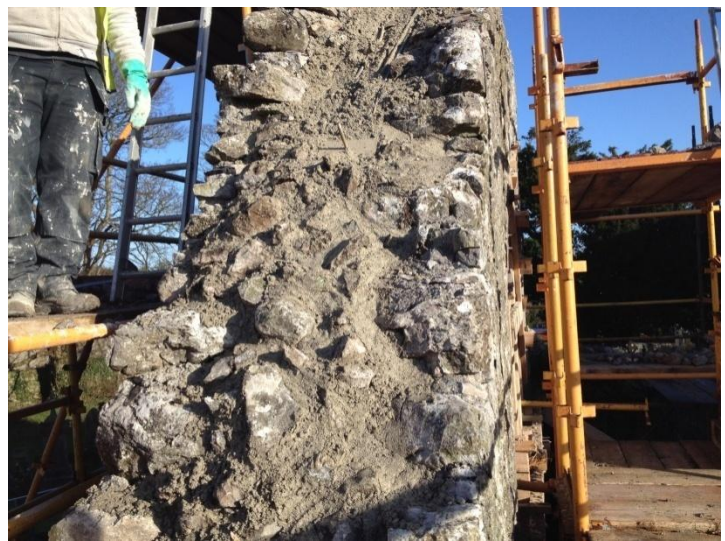
West side of gable during works, rough racking underway

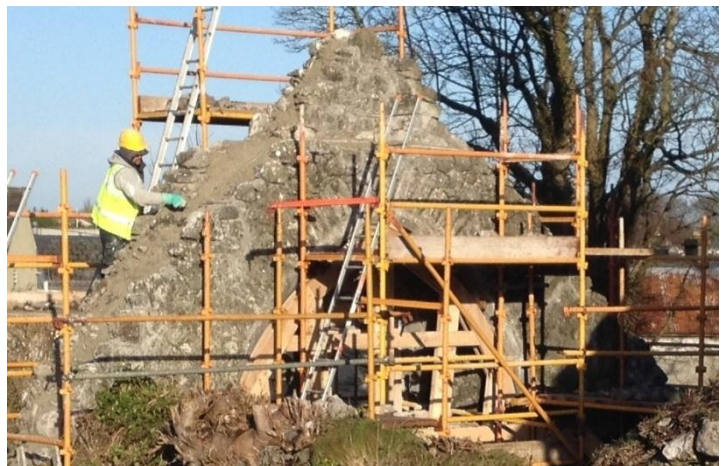
Views of limecrete under-barge with stainless steel reinforcing bars being put in place.

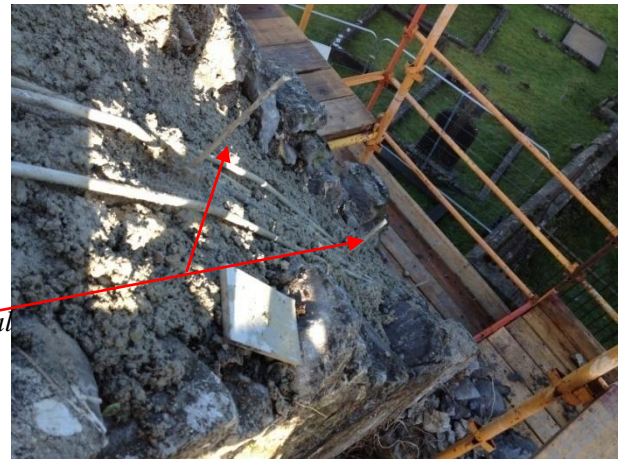
Hole drilled for insertion of threaded bar

Markers for later insertion of ss pins following initial set of limecrete under-barge. Wall was drilled and pins inserted as per Eng. spec.

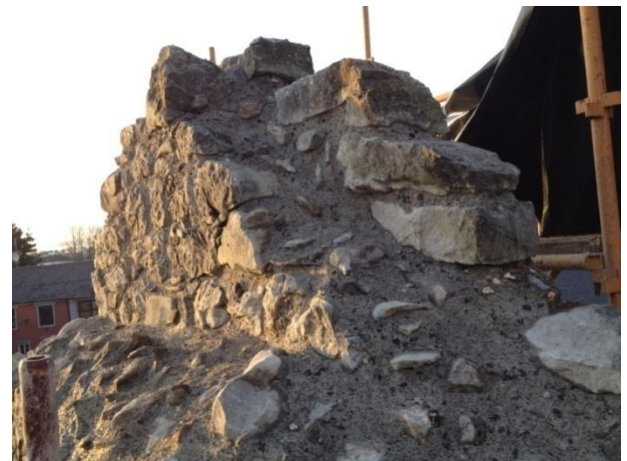
Rough racking complete on top of gable.

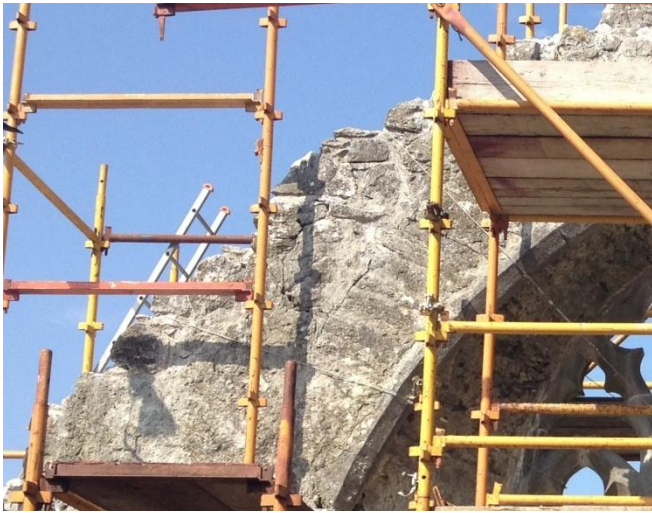
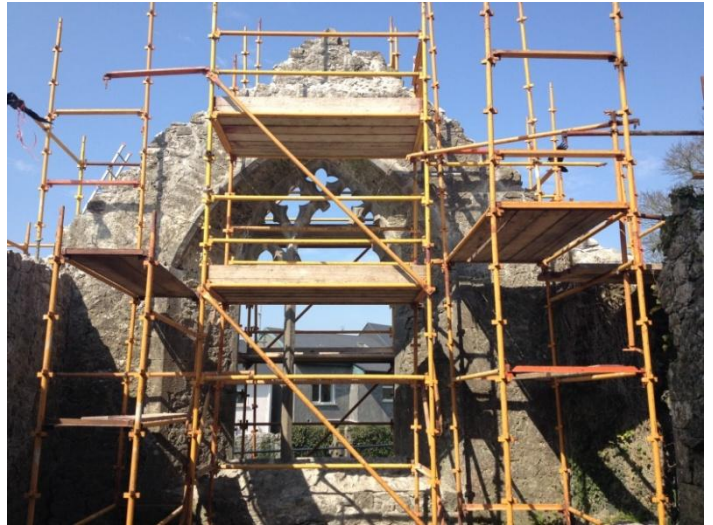
Below, general views internal face, work near complete.

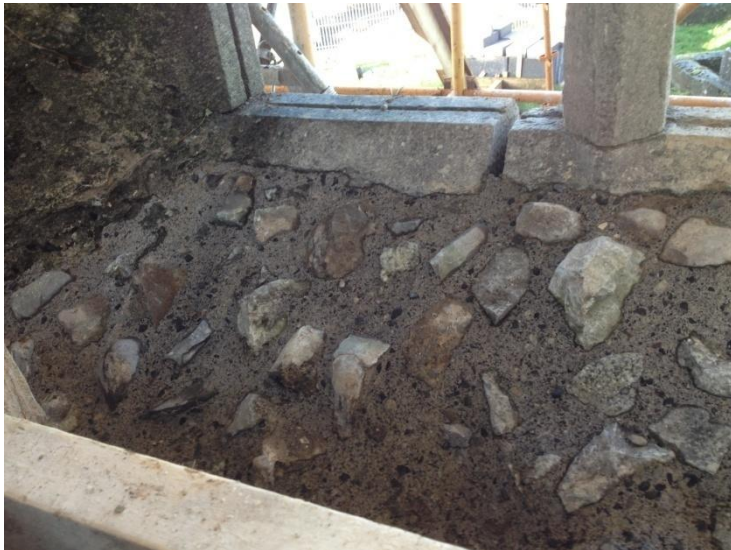
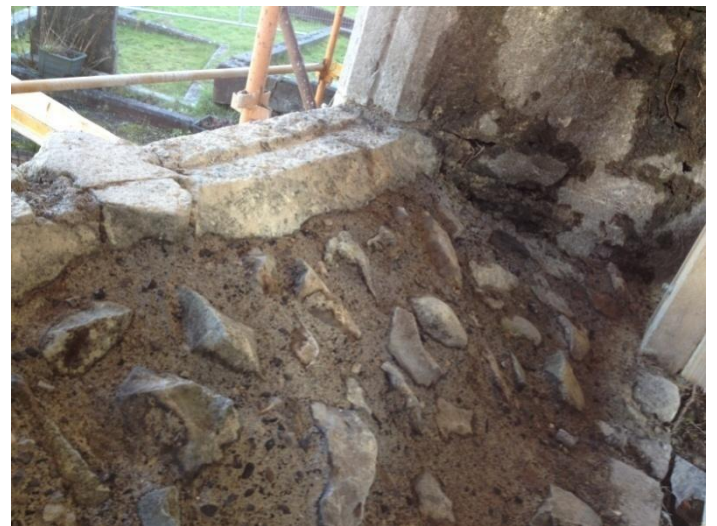
Above, rough racking of sill nearly complete

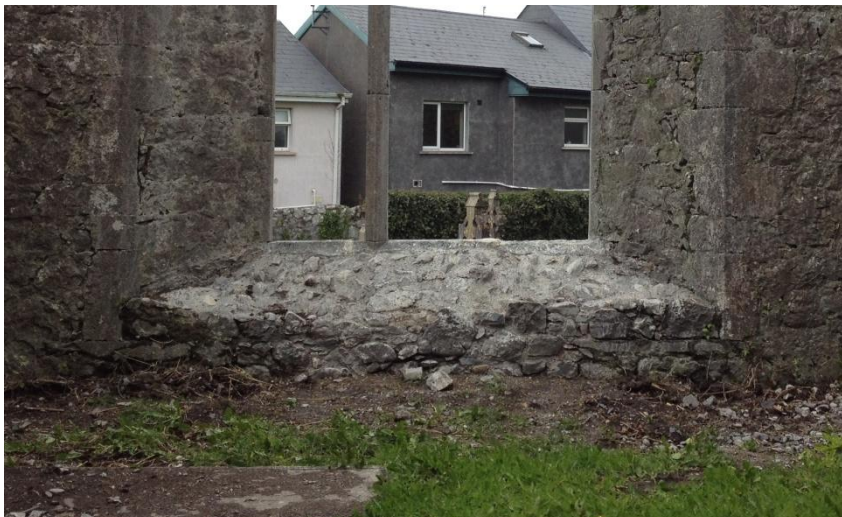
*Completed consolidation
of sill.*

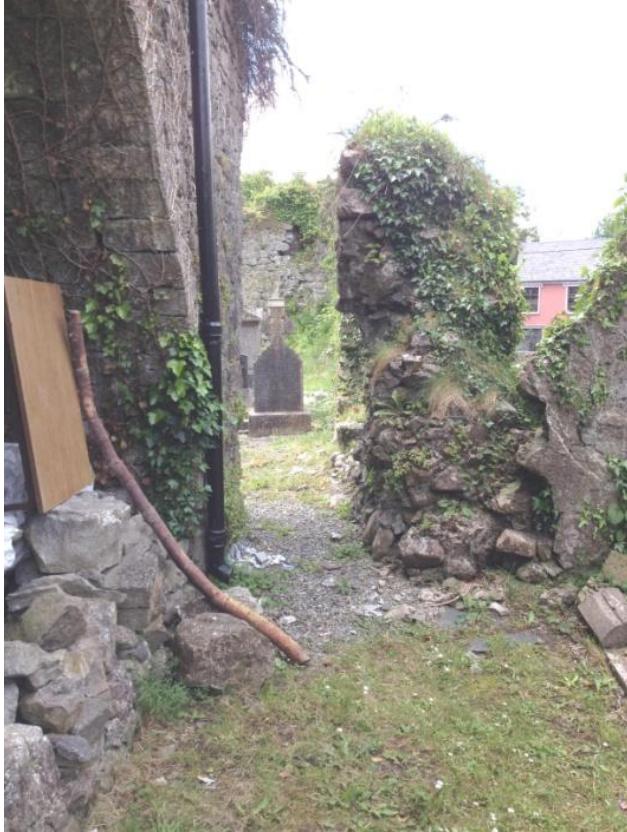
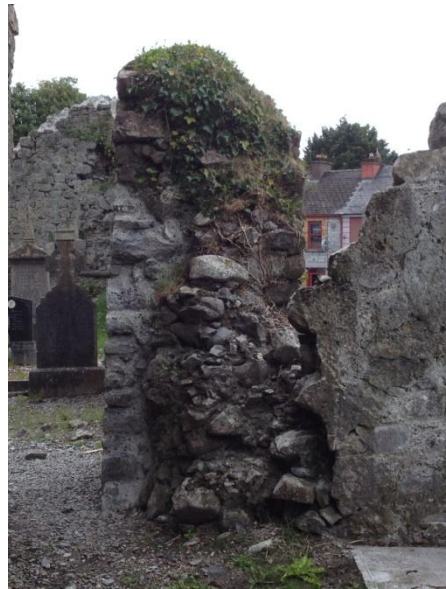
Side view (from east) showing rebuilt wall face

Same view showing wall prior to works.

Repair in this area consisted of the rebuilding of masonry where necessary to support overhanging unstable facing stones at higher levels. Because of the relatively shallow depth of the missing facing stones it was necessary to build the new masonry out to the face of the wall. It was not possible to achieve sufficient stability by using shallow stones and keeping back from the wall face and finishing 'rough raked' which was successfully done elsewhere. Re-pointing and pinning was undertaken where necessary.

Stone used was sourced from stone dump in north corner of the graveyard. This work was done early in the job so that the best quality facing stones could be chosen from the stone dump. (Facing stones were not generally required for consolidation in other parts.)

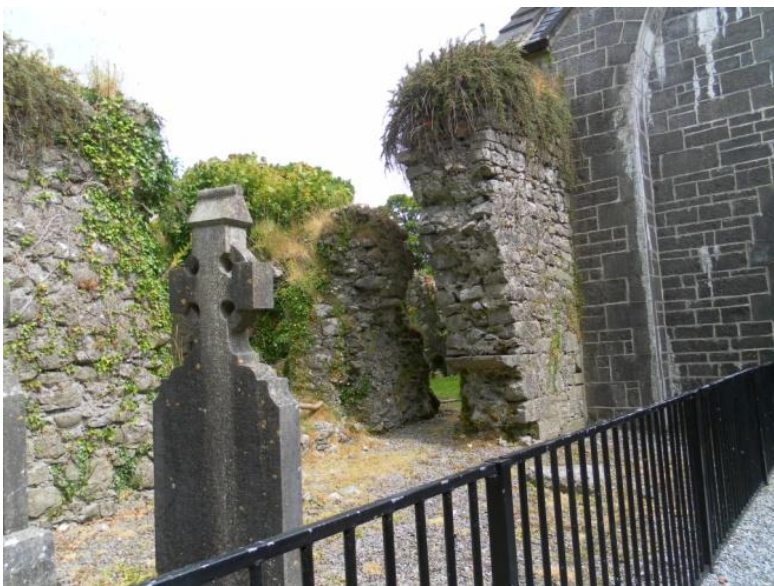
View of wall prior to repair

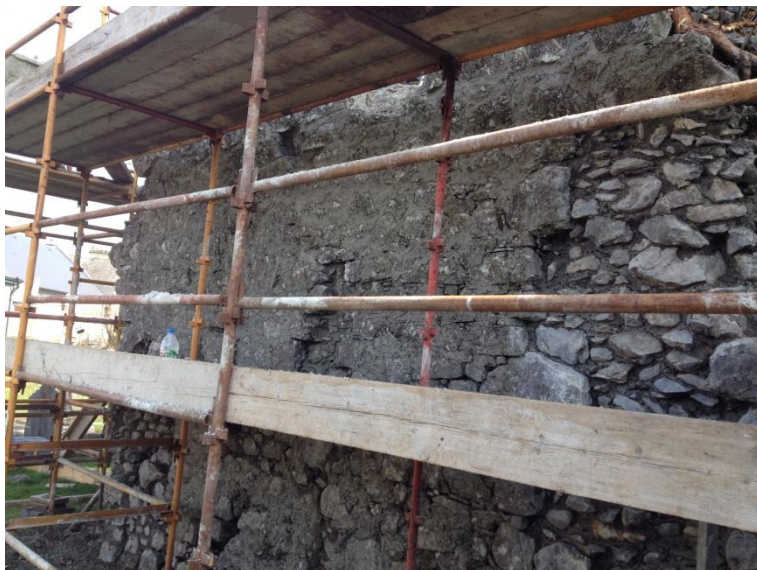
Rough racking underway on west face

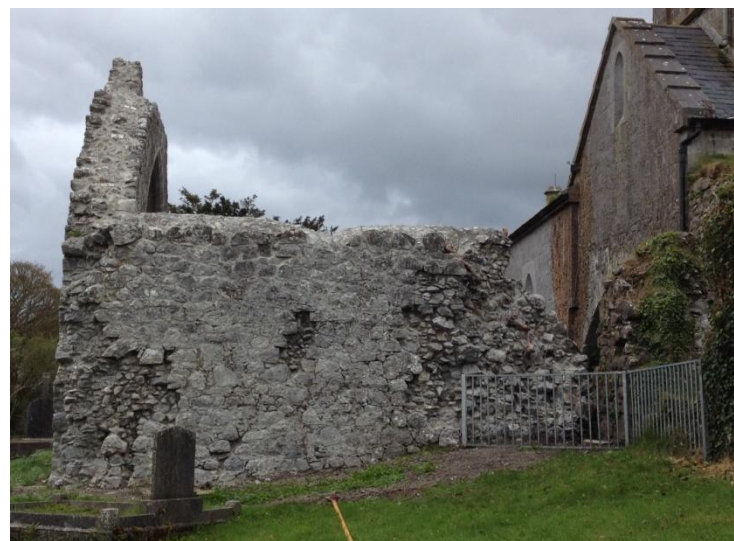
Consolidation of west face complete

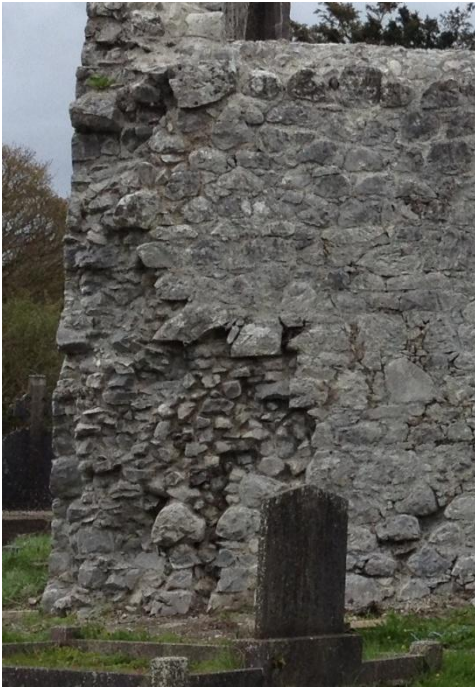
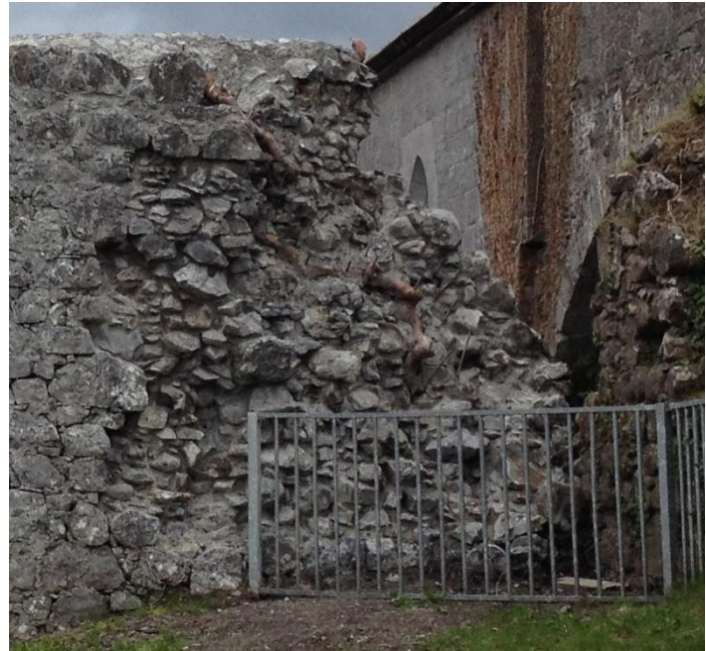
Close-up views of consolidated west face, and wall head.

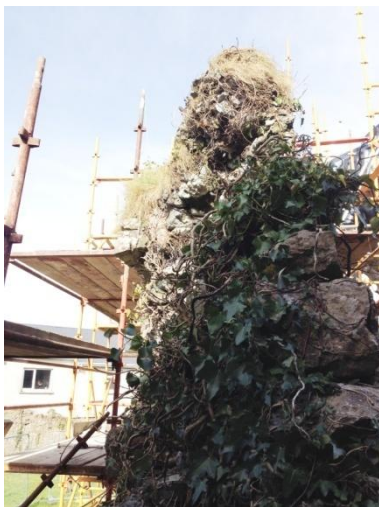
Views (on the left) of west wall from south, prior to works

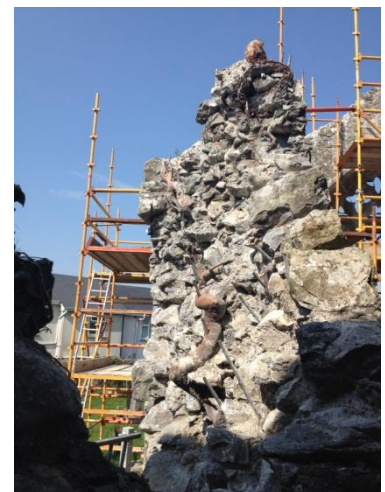
Views (on the right) of west wall from south following removal of much vegetation. Large roots had to be left in place.

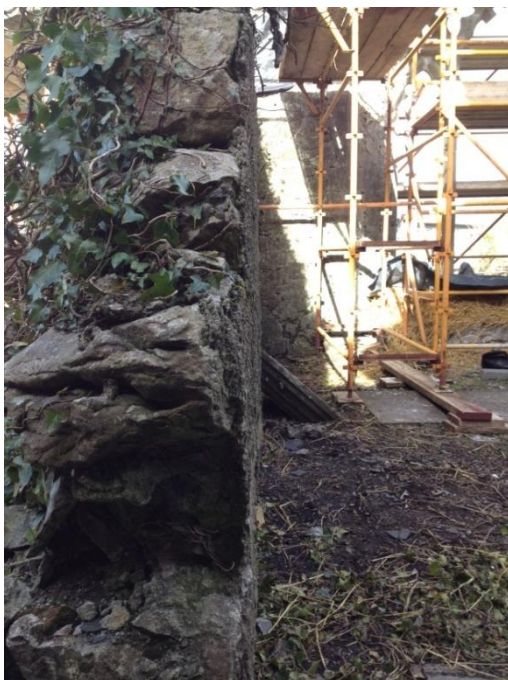
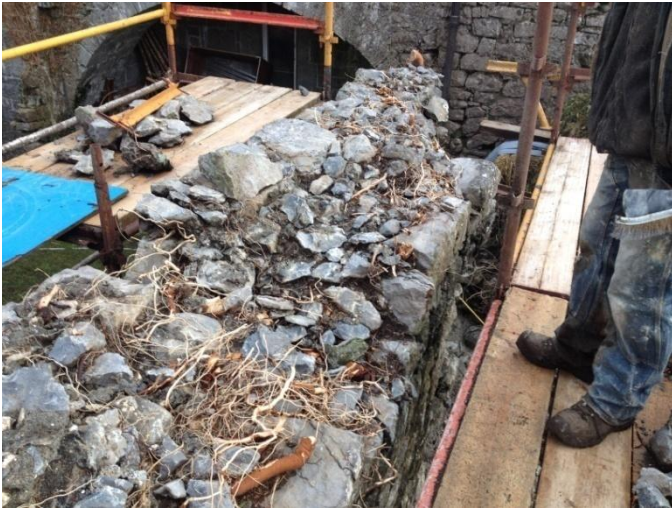
Extensive vegetation growth had done much damage to this section of the structure. Repair work included the treatment and careful removal of as much vegetation as possible. There was a huge build up of humus and soil on the wall head which had to be removed. This entailed the unavoidable dislodgement of small stones from the core of the wall and it was also necessary to re-bed some facing stones at the top of the wall. Small stones were saved and reinstated during rough racking of the wall head.

Views of the wall head during removal of vegetation and soil and humus.

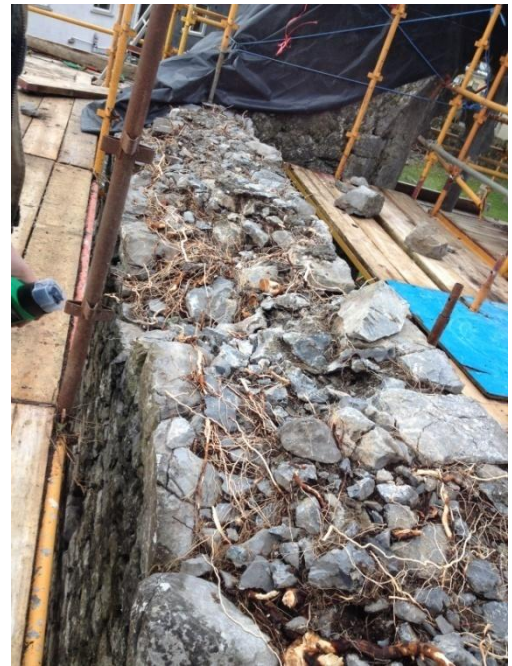
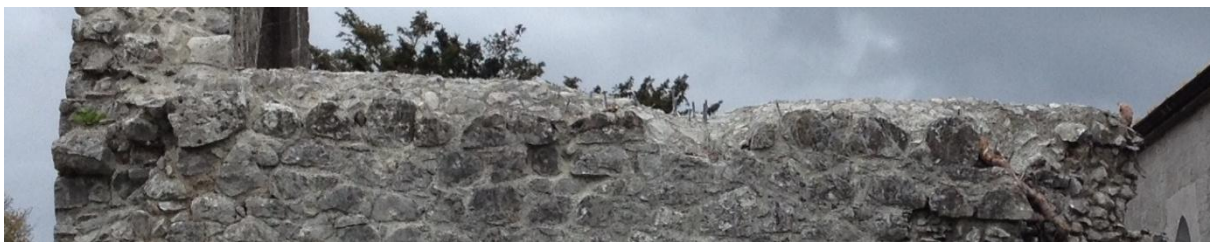
Wall head following consolidation.

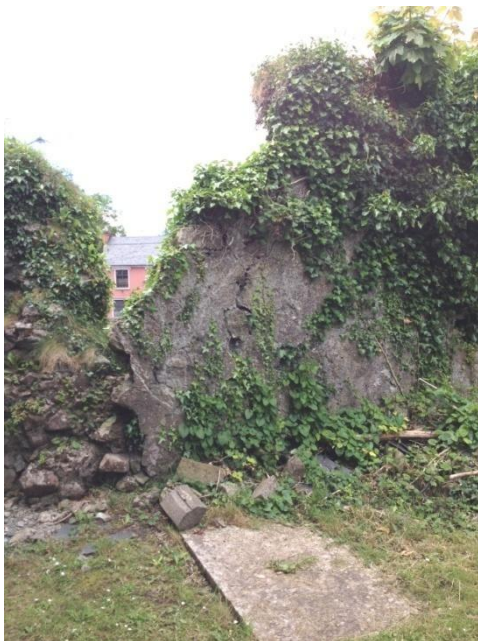
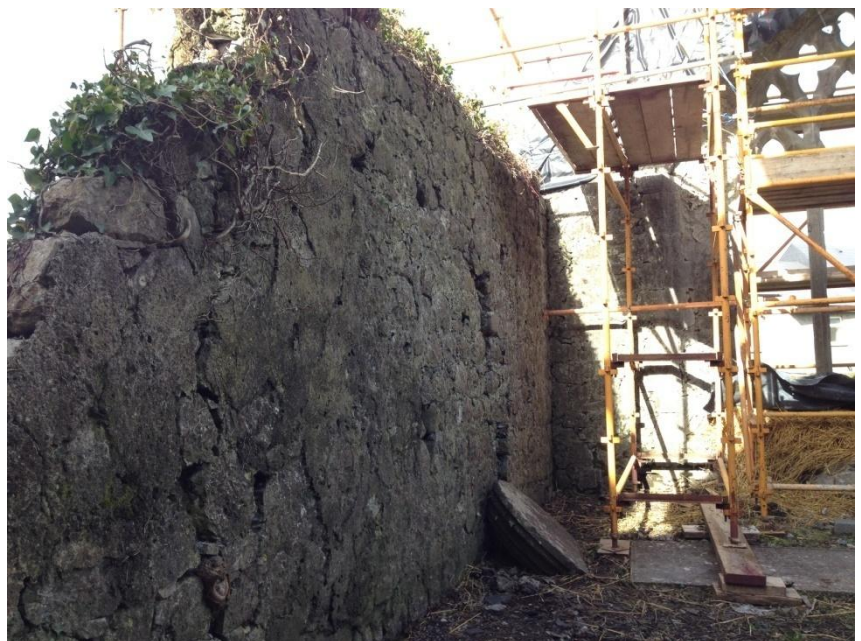
View (on left) of inside (east) face of west wall prior to works and (on right) following removal of some vegetation.
