St. Mary's Conservation Project

St. Mary's Church, Athenry, Co. Galway

Conservation Architect's Report on Works undertaken Dec 2014 - March 2015

St Mary's Athenry.**Conservation architect's report on consolidation works commenced Dec 2014**

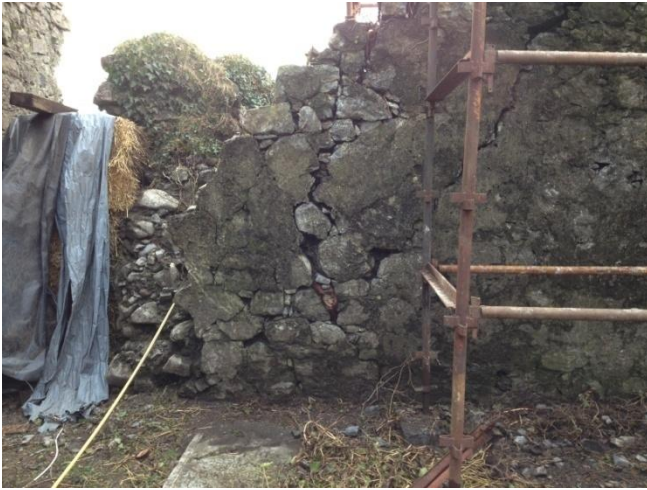
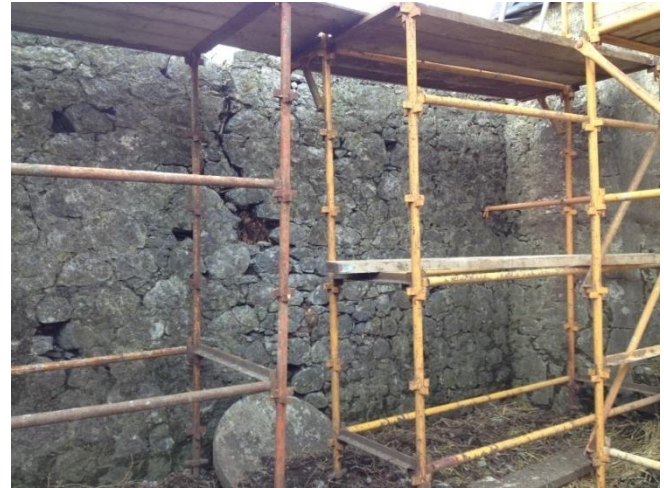
Views of inside face prior to grouting and re-pointing.

The wall was grouted using tubes inserted on both sides of the wall. As the root systems die back this will give rise to voids in the wall fabric. However the grout inserted during this repair will help to ensure the on-going stability of the wall. It will be necessary to monitor the condition of this part of the structure, and, indeed, the whole structure, into the future.

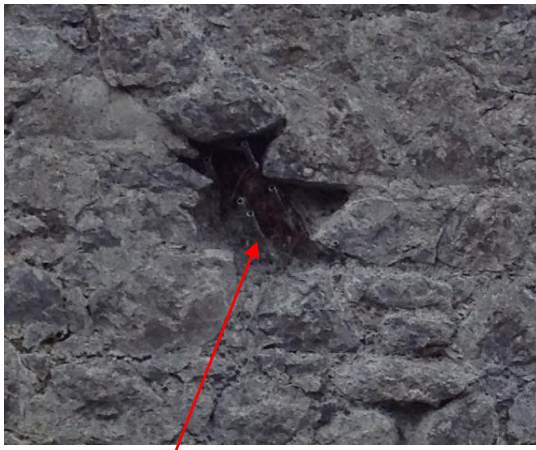
Close up showing tubes left for application of weedkiller

'Round-up was used to treat vegetation. ('Brushwood' which contains triclopir was not obtainable)

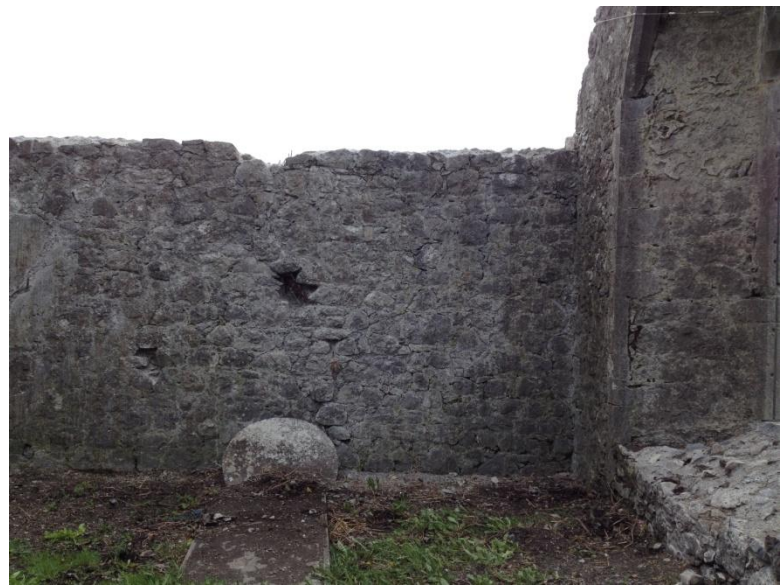
View of inside face following grouting and re-pointing

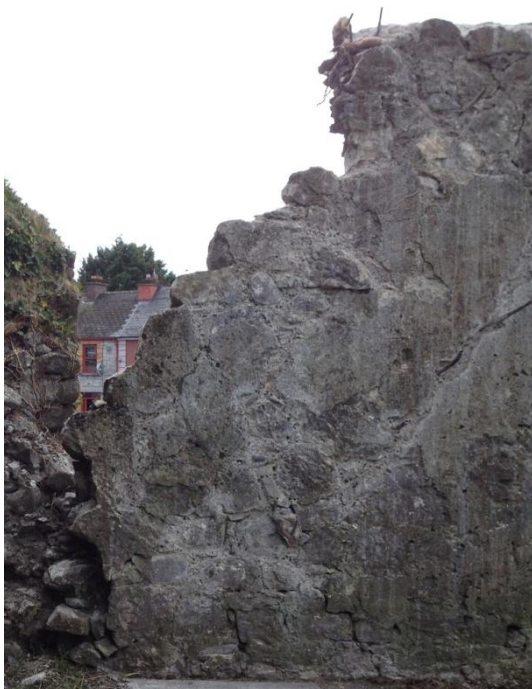
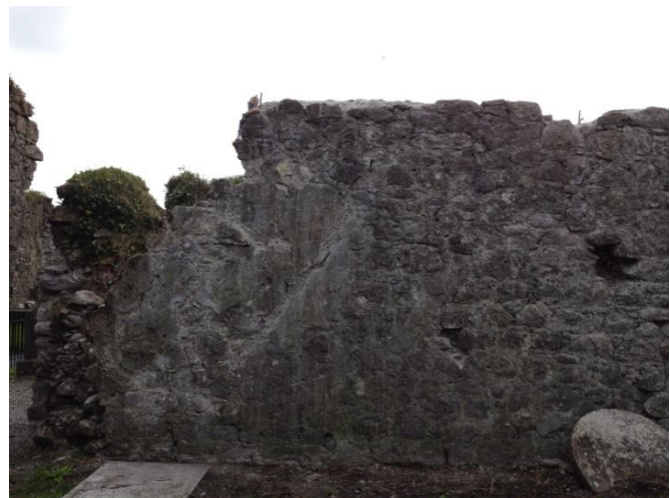
Views of south end of inside face of wall following consolidation.

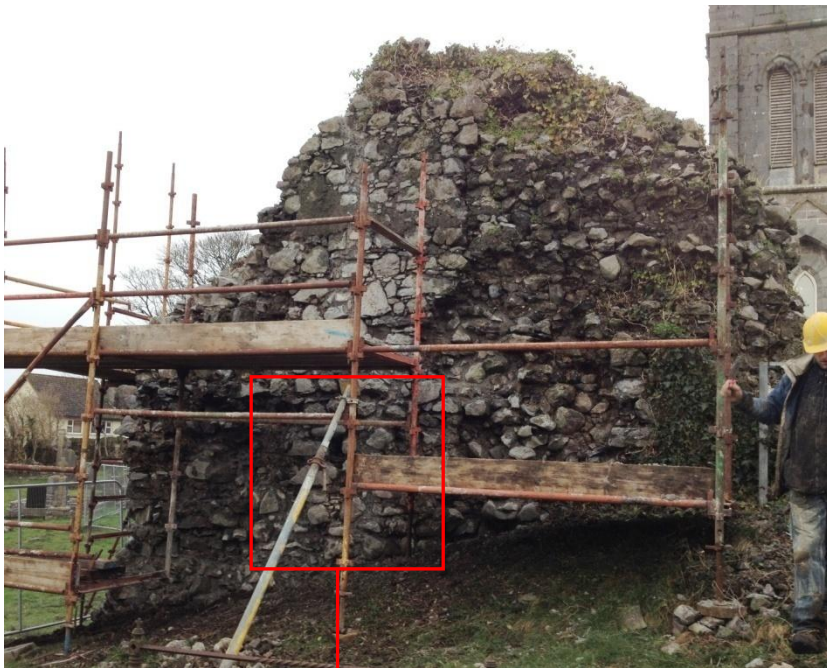
Outer face during re-pointing and consolidation

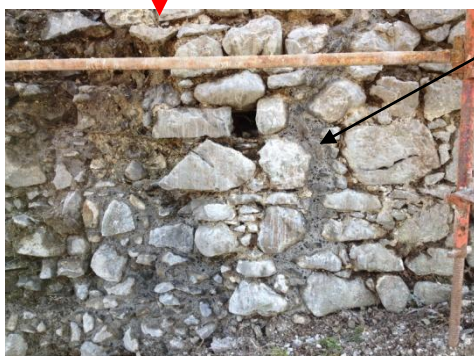
Close up view of lower part of wall.

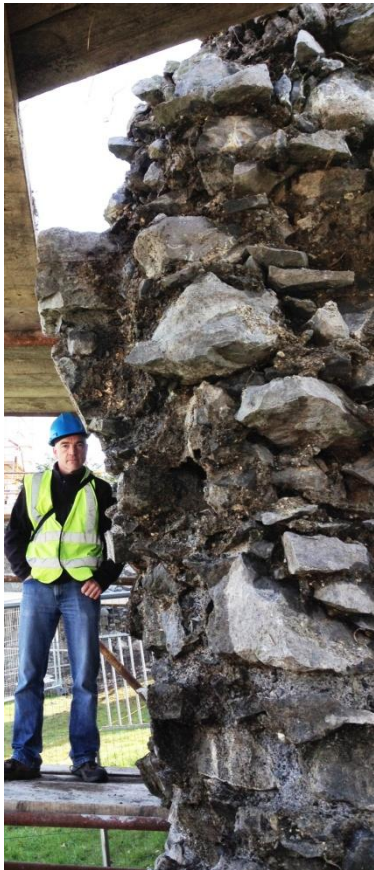
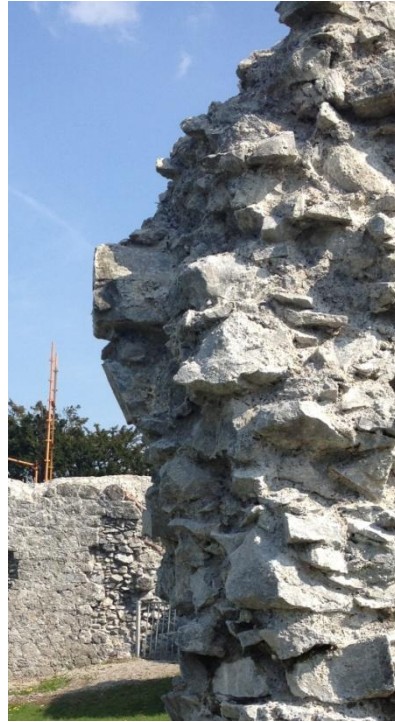
*Views of buttress from west before works (left) and after works (right)
Small stones and pinnings were inserted to stabilise overhanging stones.*

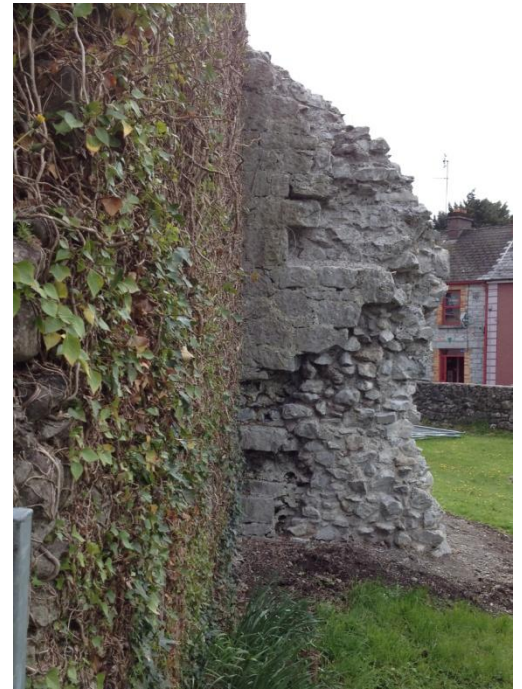
View of buttress from east, after works

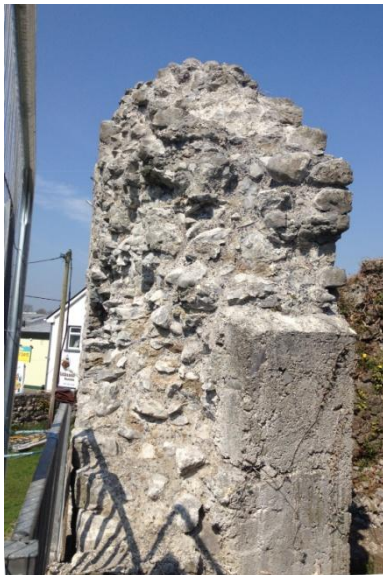
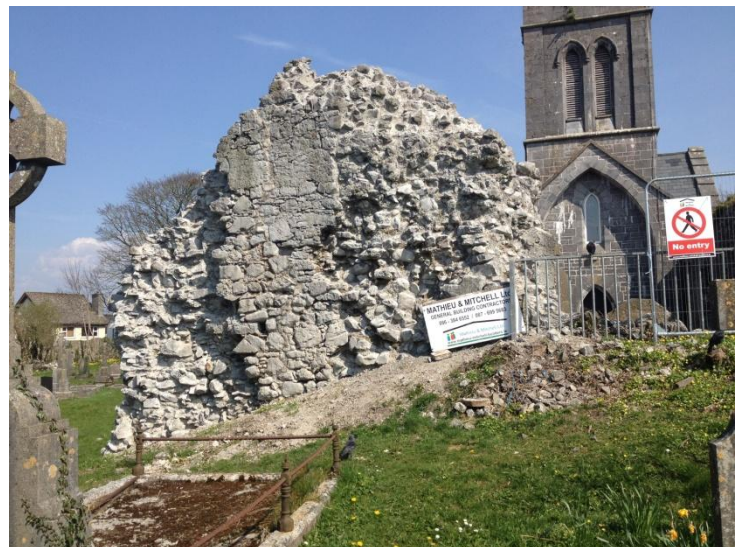
View of outside face of wall after consolidation

View of exposed wall end from south after completion of works. Note 20th century concrete repair in foreground.

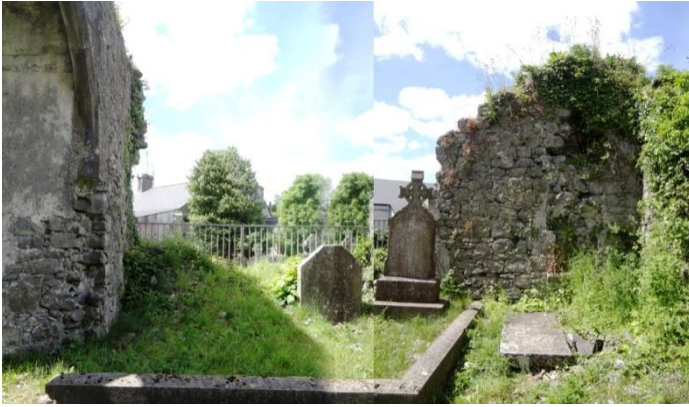
View of inside (east) face prior to works

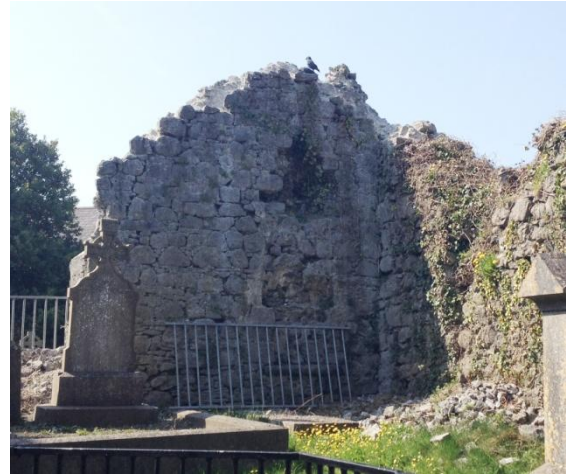
Inside face after works. Works to the inner face consisted of the removal of vegetation and the consolidation of the wall head.
